# Geotechnical Report for Food Cart Pods

12675 SW 1<sup>st</sup> Avenue  
Beaverton, Oregon

Prepared for:  
Ray Veillet

4 November 2021 2021

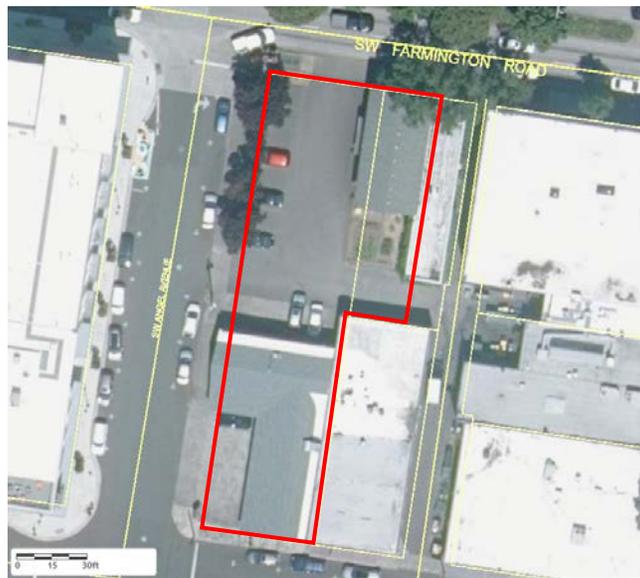
The northern half of the property is currently vacant and undeveloped. A foundation is present where a building once stood. This building was recently demolished. It was a two-story structure with no basement. County records indicate that the structure was constructed in 1910. The freestanding structure was around 2,500 to 3,000 square feet. The previous tenant of the structure was a vintage clothing shop. A small square of property directly south of the structure historically contained a plot of land periodically utilized for growing vegetables; at the time of the site visit this patch of ground contained short grasses. A row of grape vines appears to be growing along the property line and onto the adjacent building. The western two thirds of the northern half of the property contains an asphalt-concrete paved parking lot. RSS observed the asphalt to be in good condition.

No standing or flowing water was observed on the subject site.

Figure 1: Existing conditions on the subject site, aerial image from 2019 and presented by Washington County Intermap.

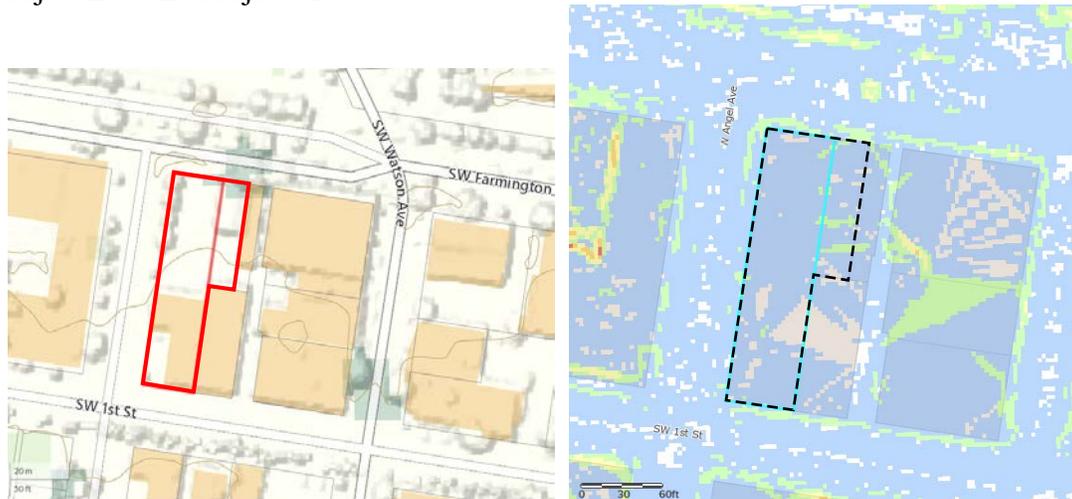
A slope model derived from a 5-ft DEM of Portland and the surrounding area suggests that the majority of the property contains slopes of less than 5%. Small areas within the subject property contain modeled slopes of 5-10%. No slopes greater than 10% are mapped on or adjacent to the subject site.

Observations of the slopes on site are constant with the modeled slopes, as presented below. Some grading may have historically occurred across the historic downtown region, as the area was developed in late ninetieth and early twenty centuries. Lidar imagery also presents low slopes, where paved surfaces are artificially smoothed. No steep slopes are observed on or adjacent to the subject site.

Figure 2: Slopes on the Site. LEFT: two-foot contours from Metro Map. RIGHT: slope model from Portland Maps. blue: <5%, green: 5-10%, yellow: 10-15%, orange 15-20%, red: >20%.

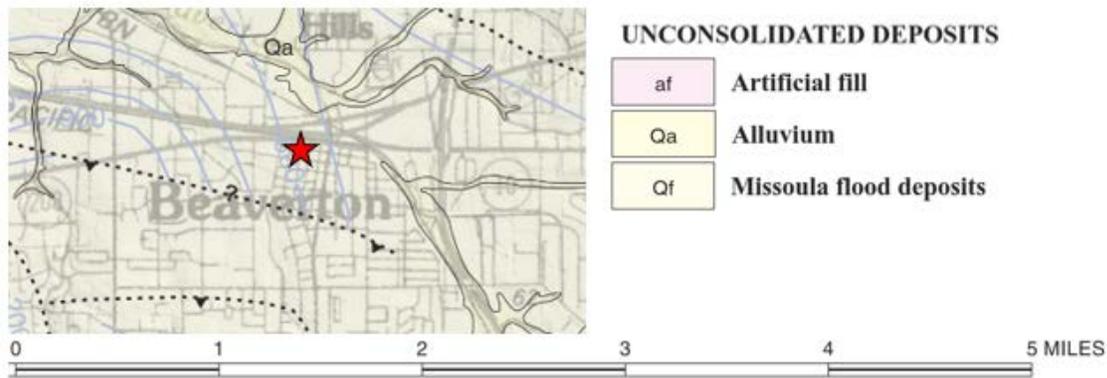
The sediments brought into the lowlands by the Missoula Floods were deposited when the waters slowed down, blanketing older fluvial and igneous deposits with swaths of rhythmic sedimentary beds. Various studies have divided the Missoula Floods deposits into distinct facies defined by grain size. The materials found at the subject site are part of the fine-grained facies.

The fine-grained facies of the Missoula Floods are described as an unconsolidated light-brown to light-gray silt, clay and fine to medium sand. The sediments are deposited in a series of distinct layers, a few inches to a few feet thick, each of which represents a single flood. The finer sediments are predominantly quartz and feldspar and also contain white mica. The coarser sediments can be comprised of Columbia River Basalt fragments. Poorly defined beds of 1- to 3-feet thickness are observed in outcrops, and complex layering has been recorded in boreholes. These deposits have been interpreted as slack-water sediments settling from the slowing floodwaters. In some areas of this unit, it can include sediments compositionally similar to loess. Soil development commonly introduces significant clay and iron oxides into the upper 6-10 feet of the deposit.

Figure 3: Geology at the subject site, excerpt from Wells et al (2020).

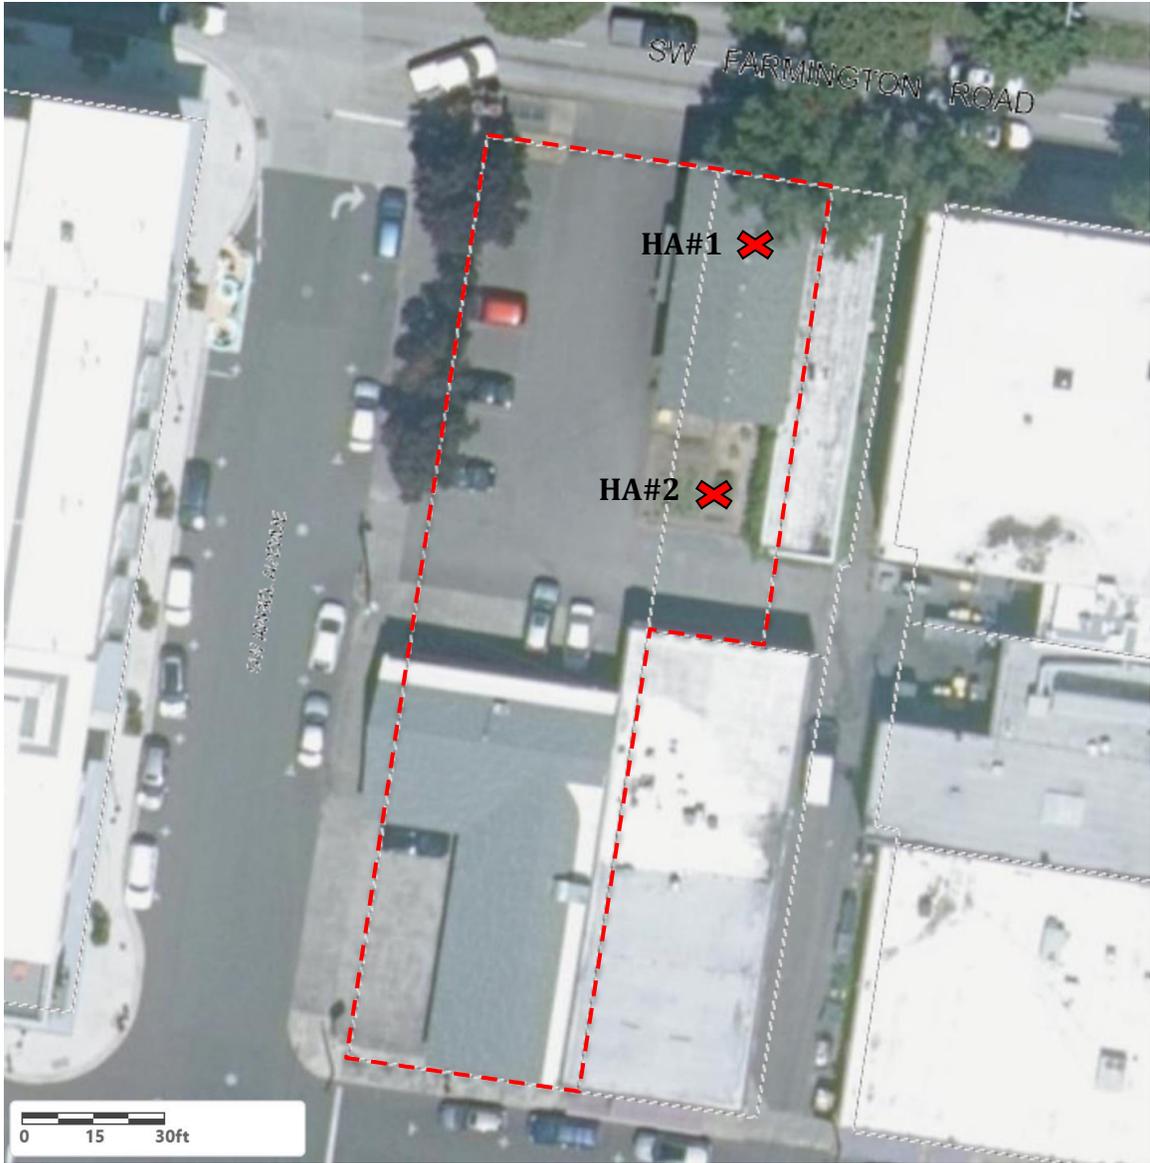
A total of two shallow hand auger borings were conducted within the subject site. One boring was conducted within the soils of the now exposed crawl space. RSS observed a minor amount of fill within the crawl space, presumably backfill comprised of locally sourced, fine-grained material. This fine-grained material was likely placed/disturbed when the structure was originally constructed and is less than 1 foot thick. The second boring was conducted in the grassy patch located at the southern edge of the now demolished structure. RSS found fill to a depth of about 1.6 feet; the fill is comprised of layers of (1) imported organic material, (2) fine grained soils, and (3) grey colored, angular, hard gravels and sand. Below the surficial fills, both borings contained interbedded horizons of silts and clays. Both borings appeared to contain a decreasing amount of clay content with depth. Both borings were conducted to a depth of 4 feet.

No groundwater was encountered during this investigation.

The locations of the borings are shown on Figure 3 in the Appendix. A Geologist in Training (GIT) observed the borings and logged the subsurface materials. The soil descriptions were reviewed by a professional engineer. The logs were created using the Unified Soil Classification and Visual Manual Procedure (ASTM-D 2488). Samples were transported in sealed plastic bags. Moisture content of the collected samples ranged from 19.8% to 27.6%.

Figure 3: Approximate boring locations on an aerial image collected from Washington County Intermap
