Impact Study A

**Natural Resource Assessment dated February 2017;
Memorandum “The Ridge at South Cooper Mountain Residential
Development Oregon Freshwater Wetland Assessment Method (OFWAM)
Analysis for Wetland G” dated January 10, 2017;
Response to request for additional materials dated March 28, 2017;
Memorandum “Wetland G Local Significance Determination”
dated May 3, 2017 by
Anchor QEA LLC**

Memorandum

**Re: The Ridge at South Cooper Mountain Residential Development Project:
Wetland G Local Significance Determination**

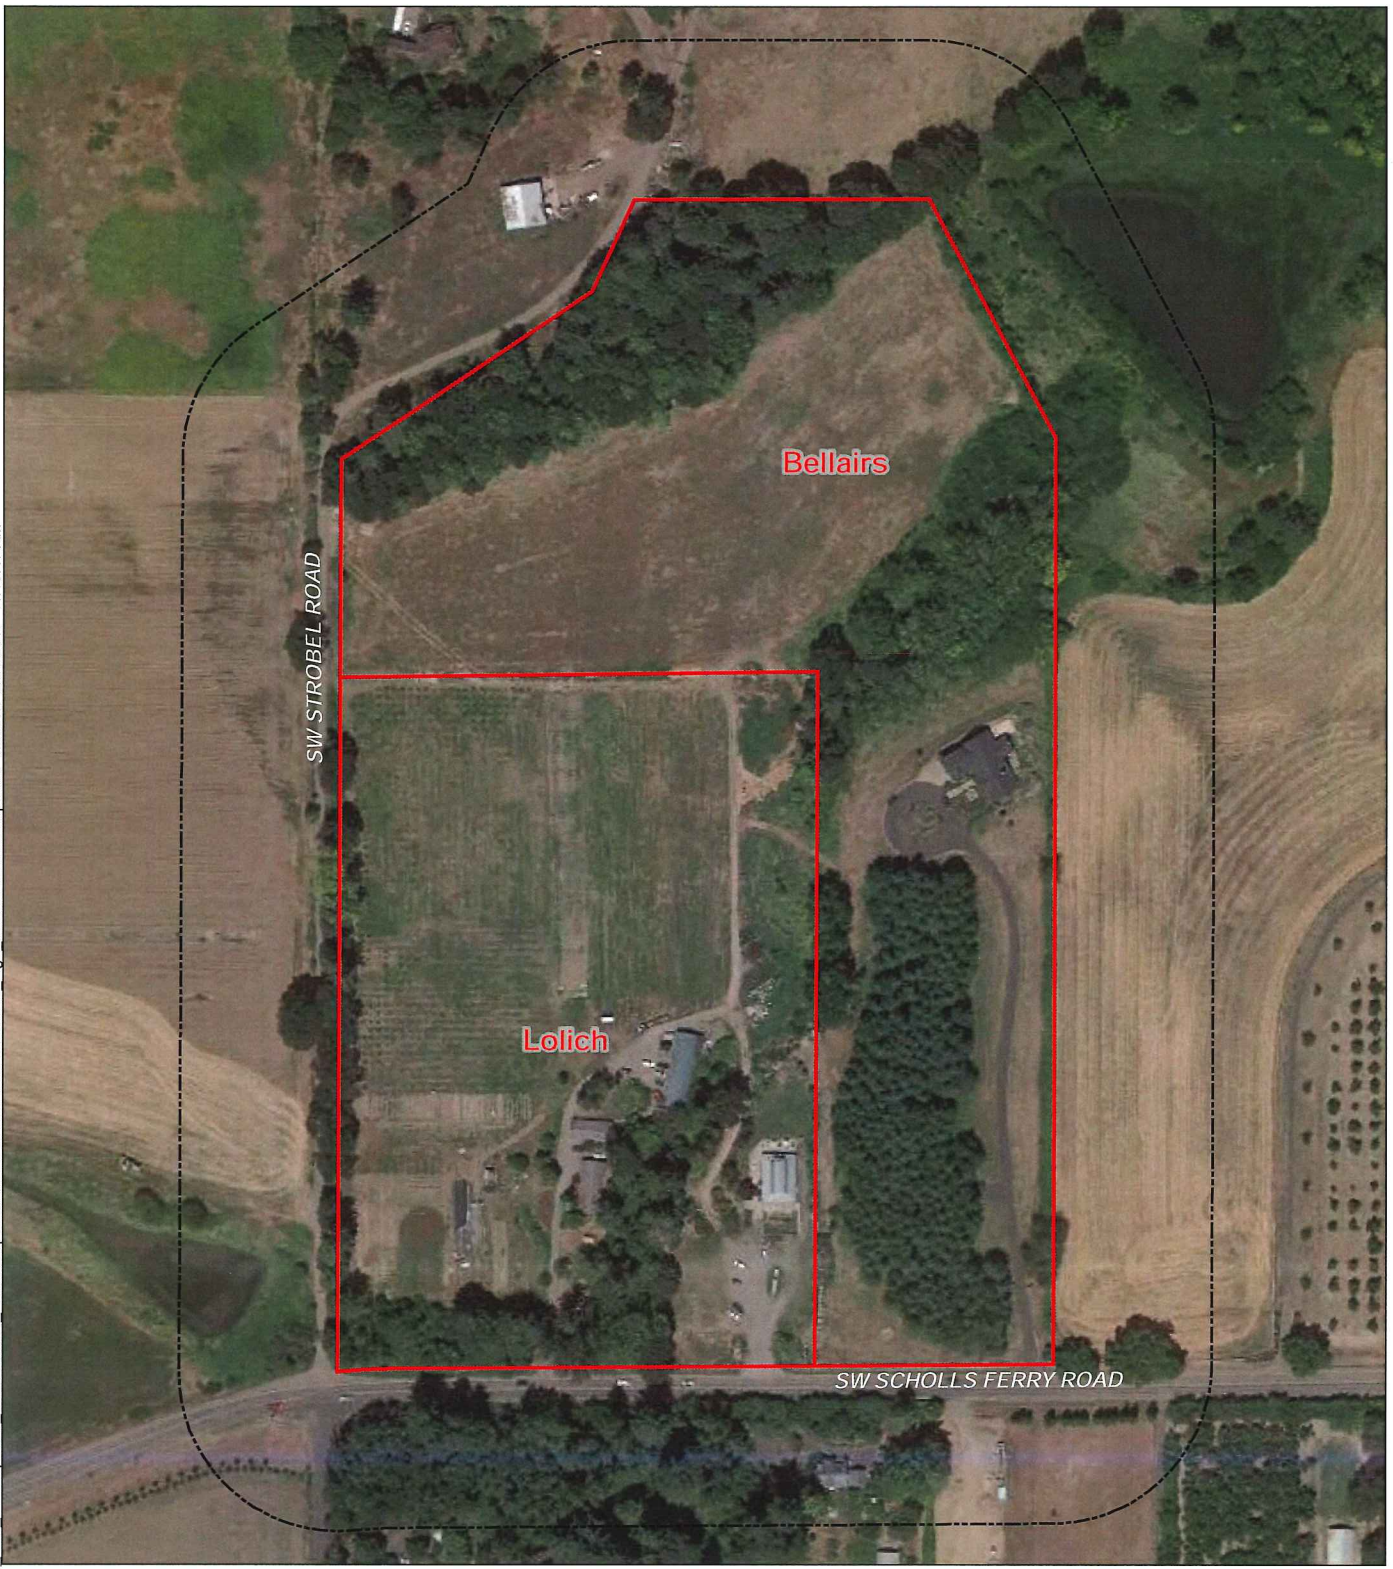
The current conditions of the study area are depicted in the 2016 aerial photograph provided in Figure 4. As indicated in the figure, the Bellairs property includes a mix of land uses including a forested area and fallow agricultural field in the northern portion, a wooded-stream corridor and single-family residence in the central portion, and a Douglas fir (*Pseudotsuga menziesii*) woodlot in the southern portion. The Lolich property is primarily composed of agricultural fields in the northern and western portions and associated agricultural buildings, including a commercial farm stand and parking lot, in the

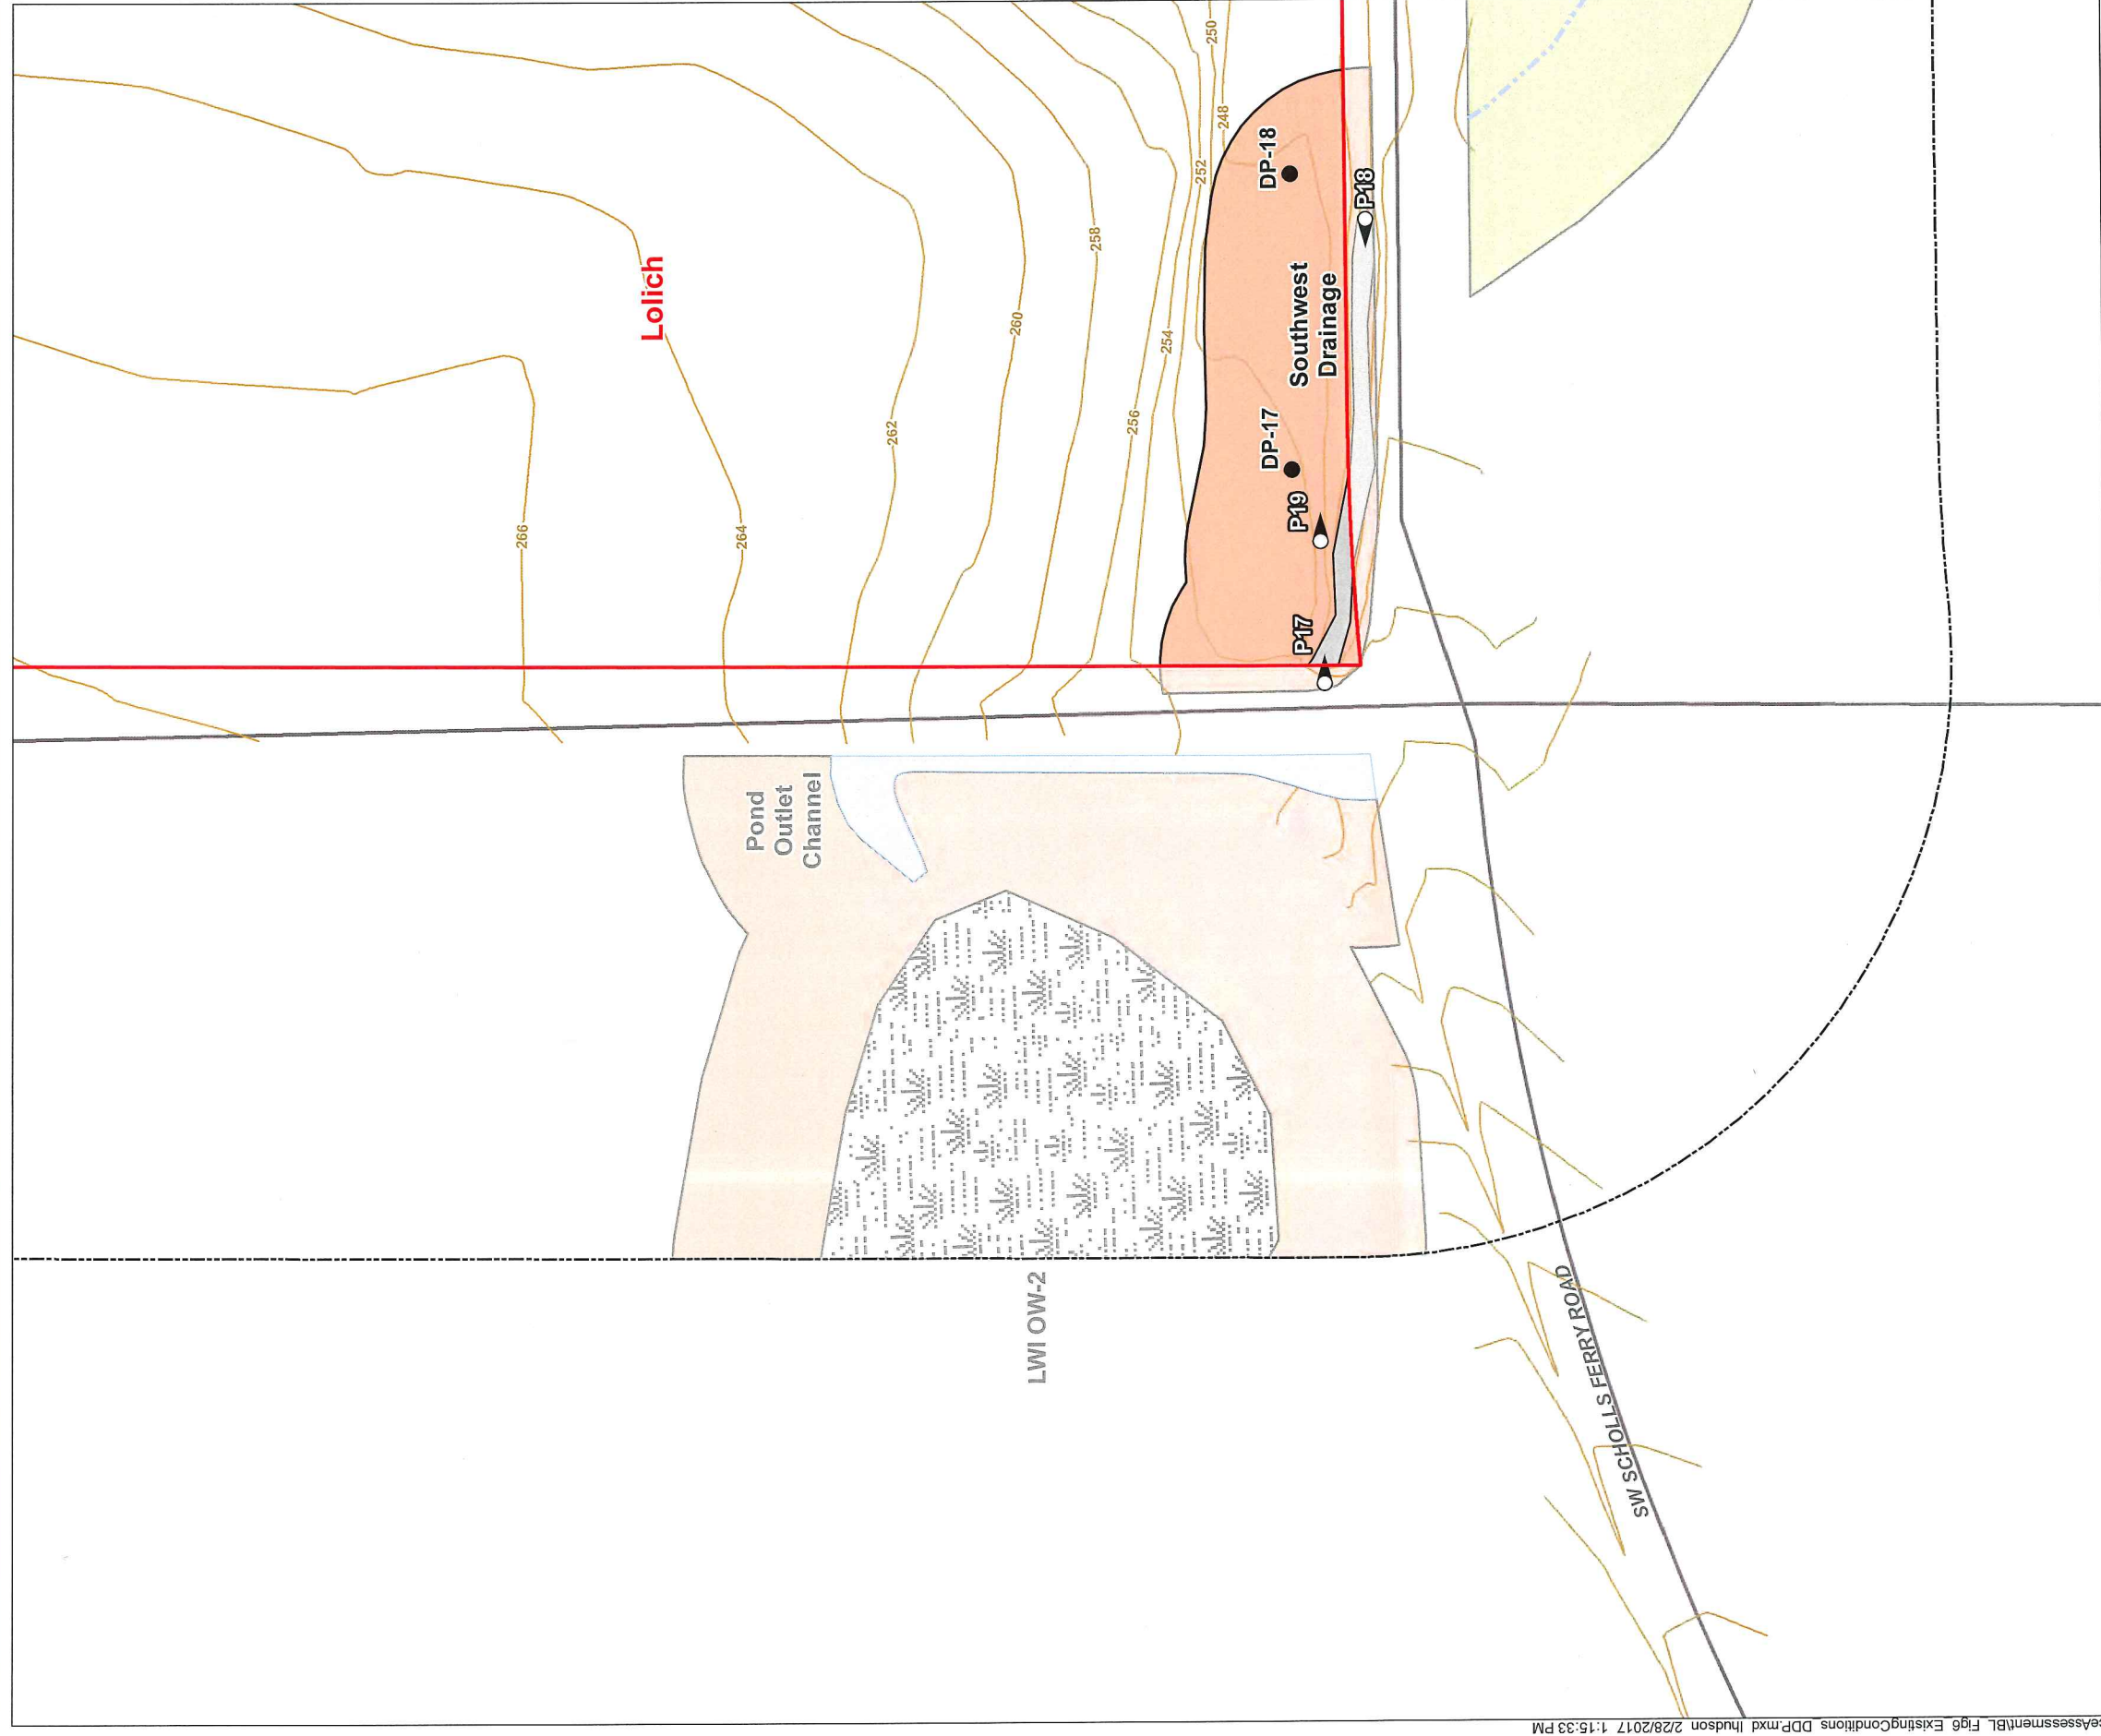
Figure 5
 Existing Conditions Overview Map
 Natural Resource Assessment (Bellairs and Lolich Properties)
 West Hills Land Development: The Ridge at South Cooper Mountain

As shown in Figures 5 and 6a through 6f, the vegetated corridors identified on the project site are predominantly in degraded condition with some marginal and good vegetated corridor condition also present.

The prevalence of degraded vegetated corridor condition is primarily due to the lack of mature overstory trees and native plant cover in many of these areas. Most of the vegetated corridors have been disturbed by both past and ongoing agricultural activities and rural development (e.g., buildings, landscaping). Typical vegetation in active agricultural areas includes colonial bentgrass perennial ryegrass, sweet vernal grass, tall fescue, field brome (*Bromus arvensis*), common velvetgrass, English plantain (*Plantago lanceolata*), common centaury (*Centaureum erythraea*), bull thistle (*Cirsium vulgare*), Queen Anne's lace (*Daucus carota*), hairy cat's ear (*Hypochaeris radicata*), Canadian thistle, and common teasel (*Dipsacus*

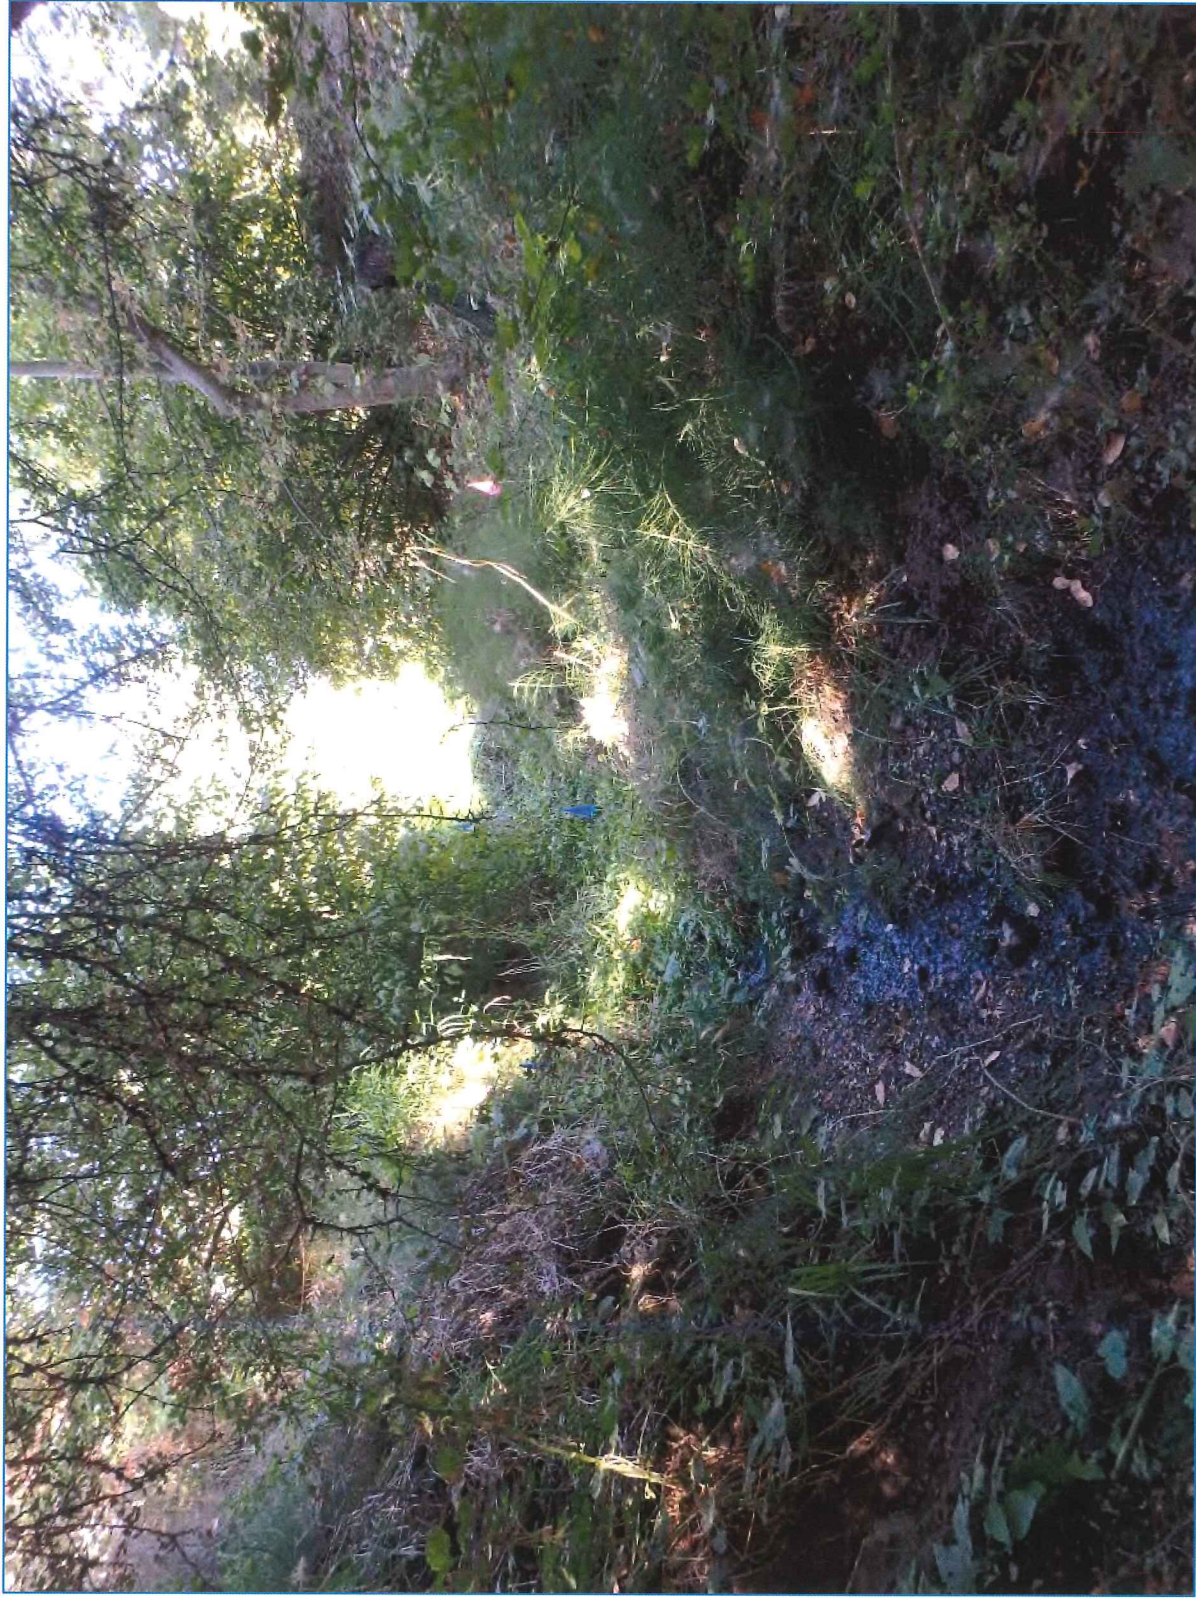
Appendix F, Photo 5

Good and Degraded Condition Vegetated Corridor along Wetland D and Unnamed Tributary, Looking Northeast
Natural Resource Assessment (Bellairs and Lolich Properties)
West Hills Land Development: The Ridge at South Cooper Mountain

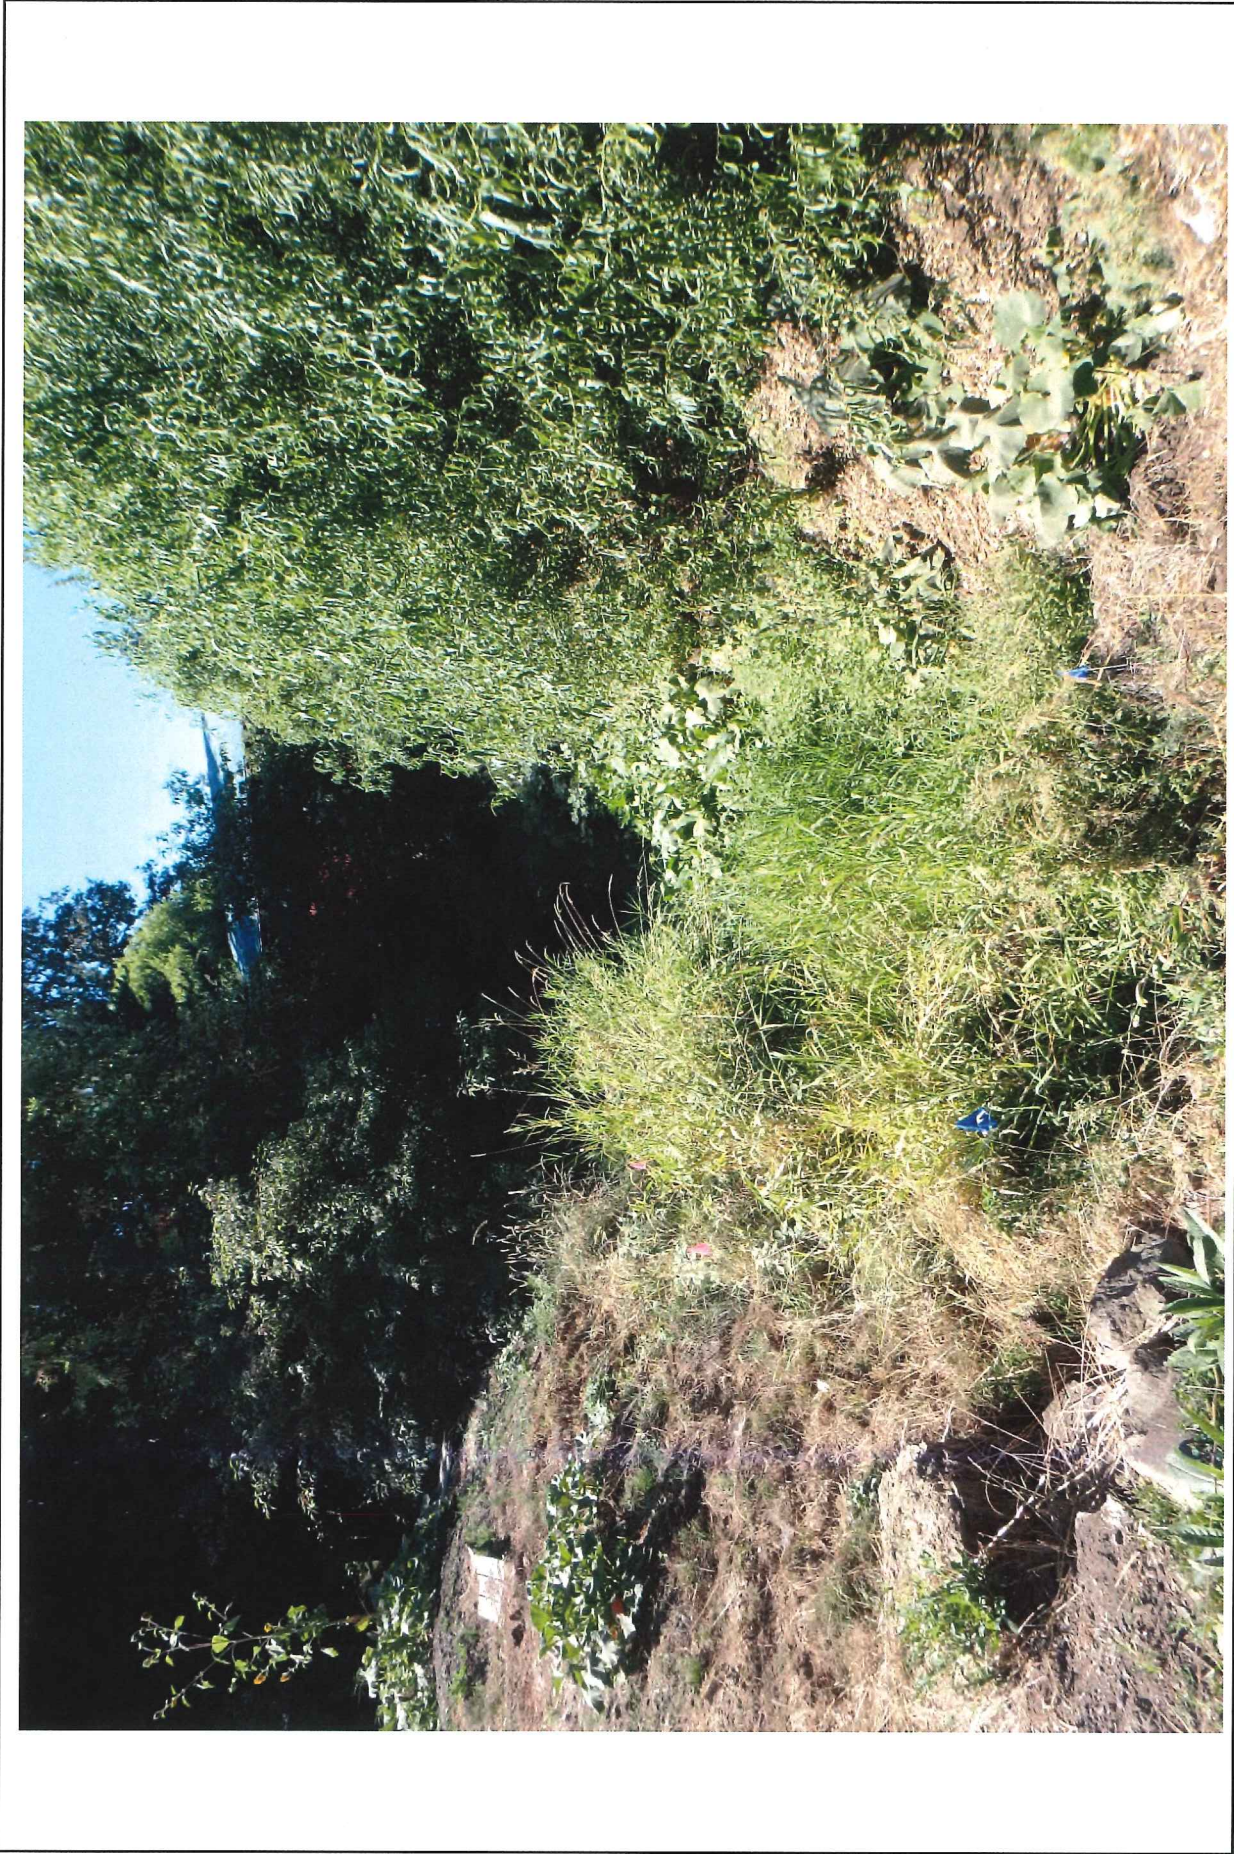
Appendix F, Photo 6
Degraded Condition Vegetated Corridor along Wetland D and Unnamed Tributary, Looking Southwest
Natural Resource Assessment (Bellairs and Lolich Properties)
West Hills Land Development: The Ridge at South Cooper Mountain

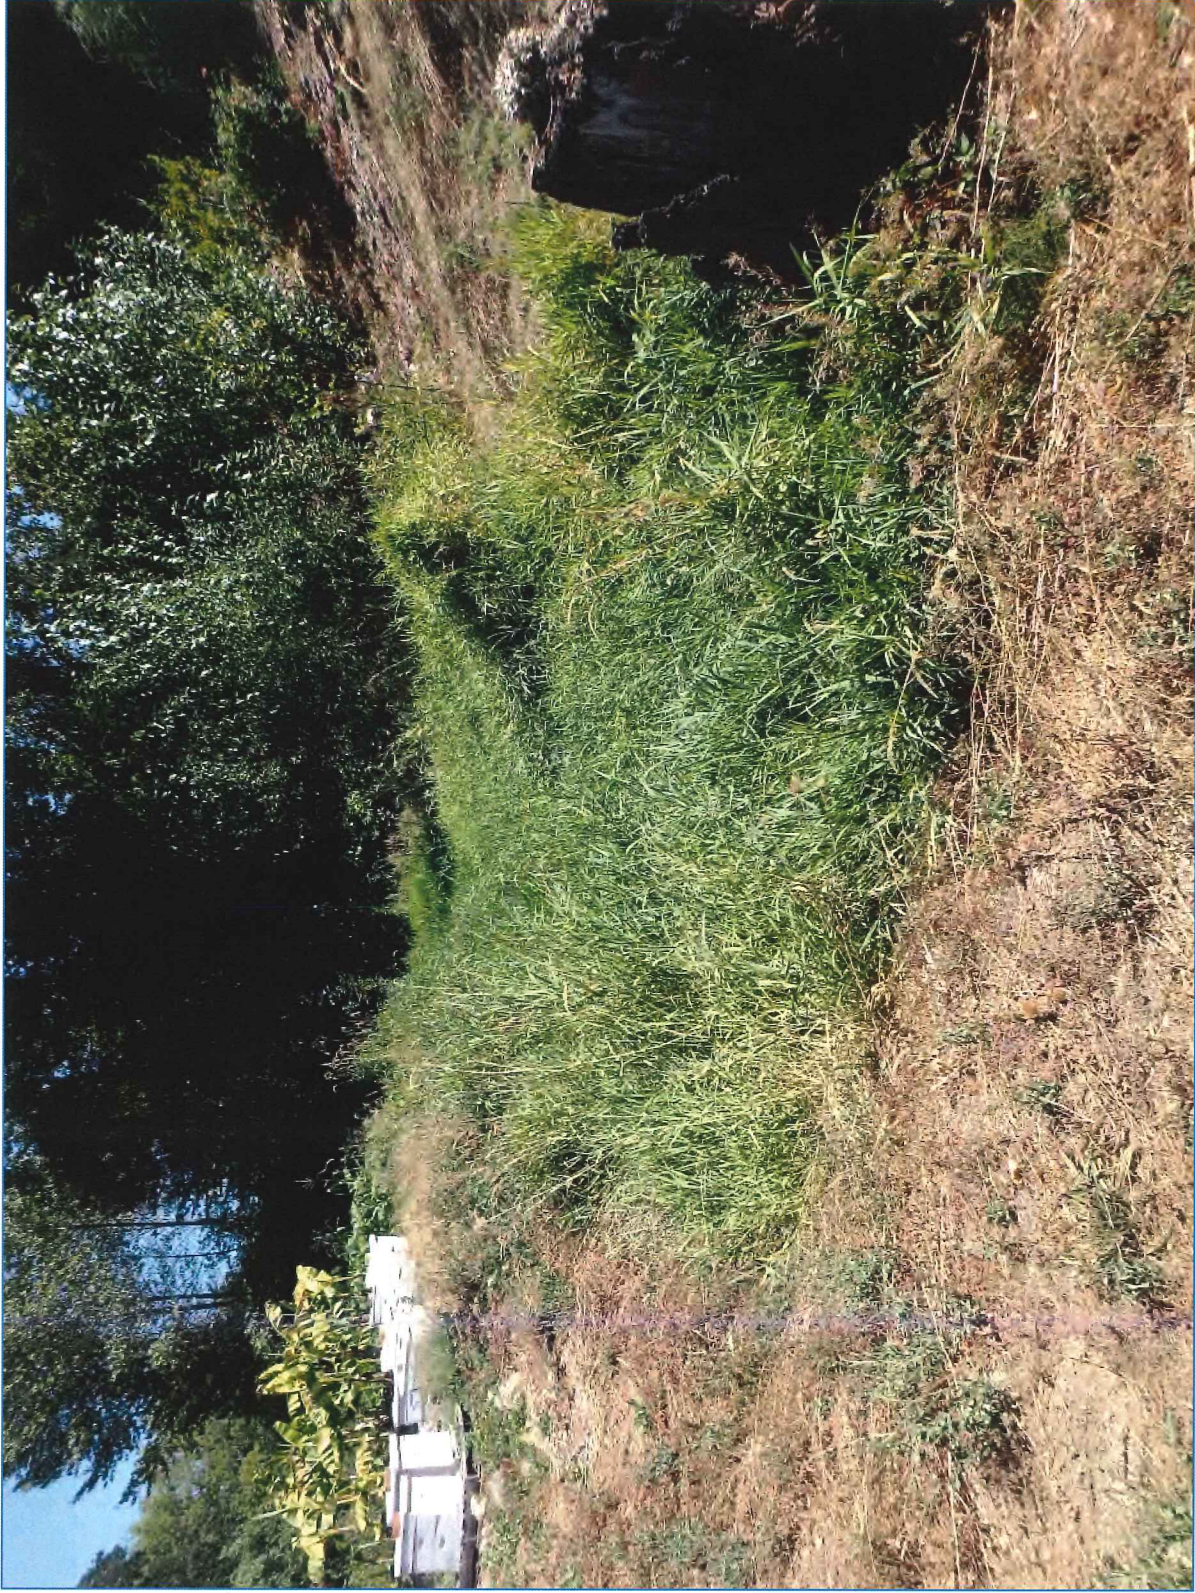
Appendix F, Photo 7
Degraded Condition Vegetated Corridor along Wetland E and Unnamed Tributary, Looking Northeast
Natural Resource Assessment (Bellairs and Lolich Properties)
West Hills Land Development: The Ridge at South Cooper Mountain

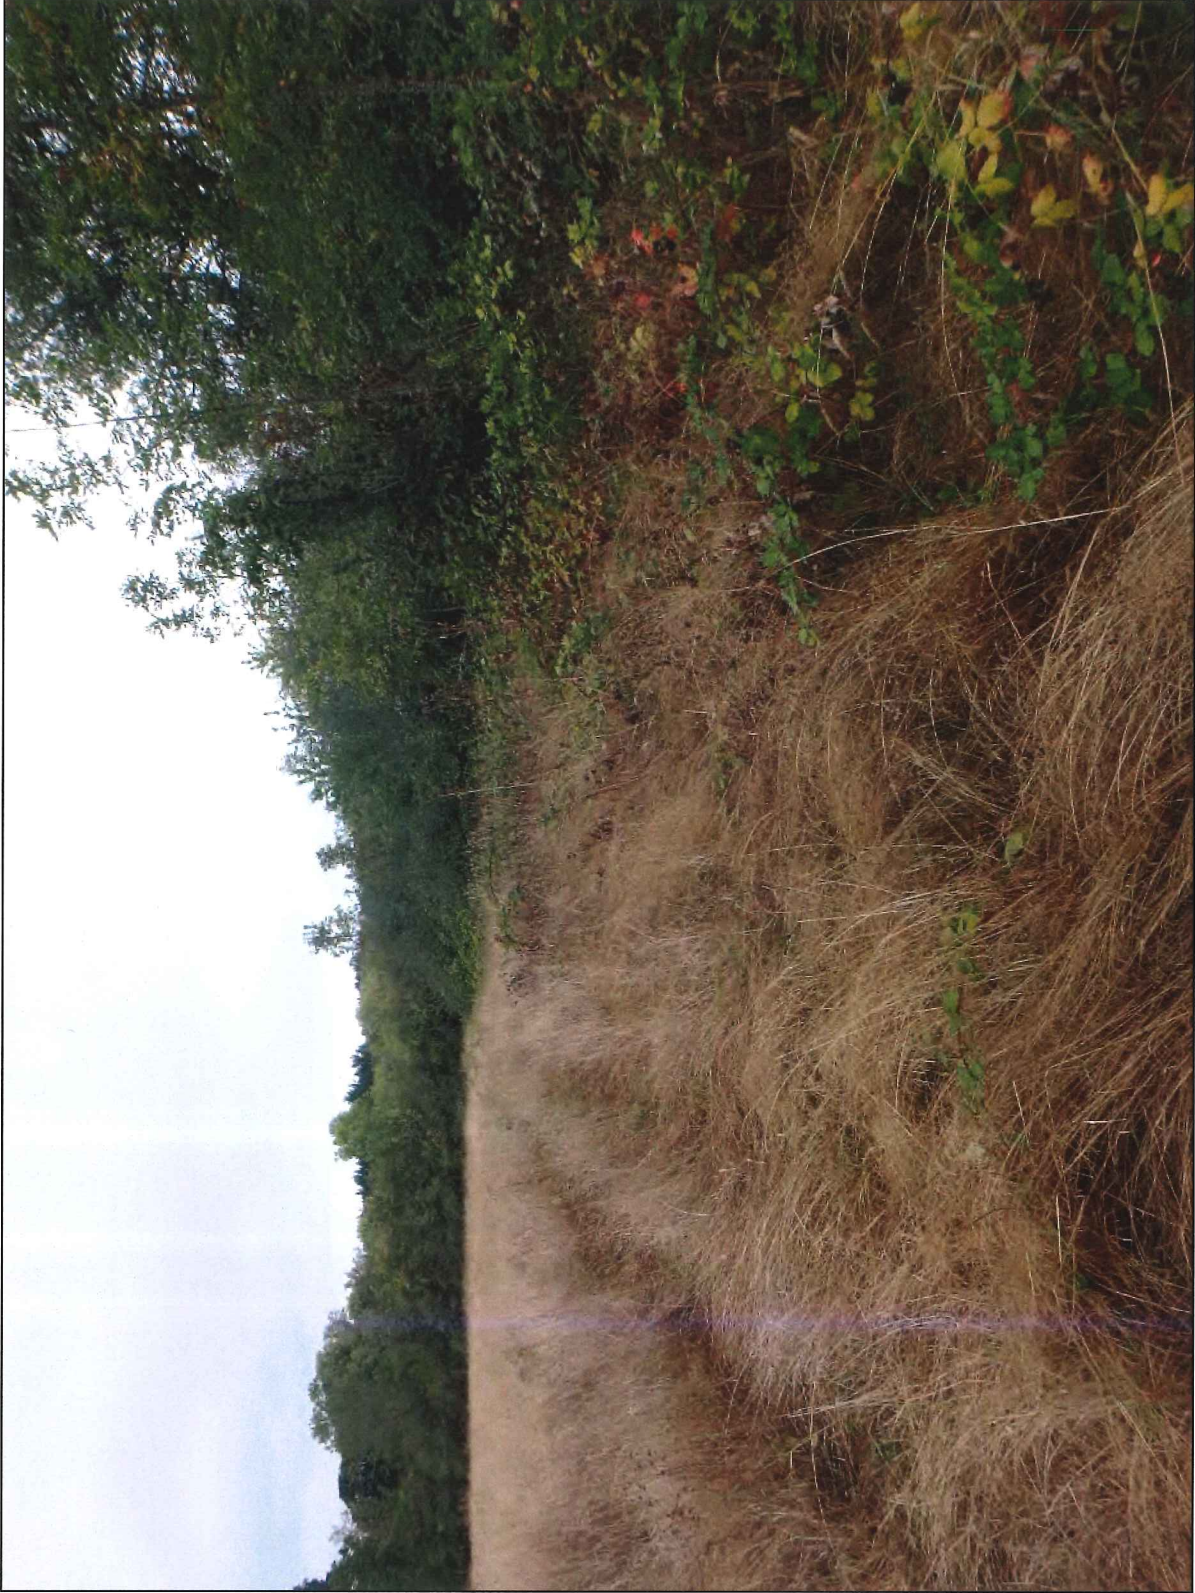
Appendix F, Photo 11
Degraded Condition Vegetated Corridor along Wetland F, Looking Northeast
Natural Resource Assessment (Bellairs and Lolich Properties)
West Hills Land Development: The Ridge at South Cooper Mountain

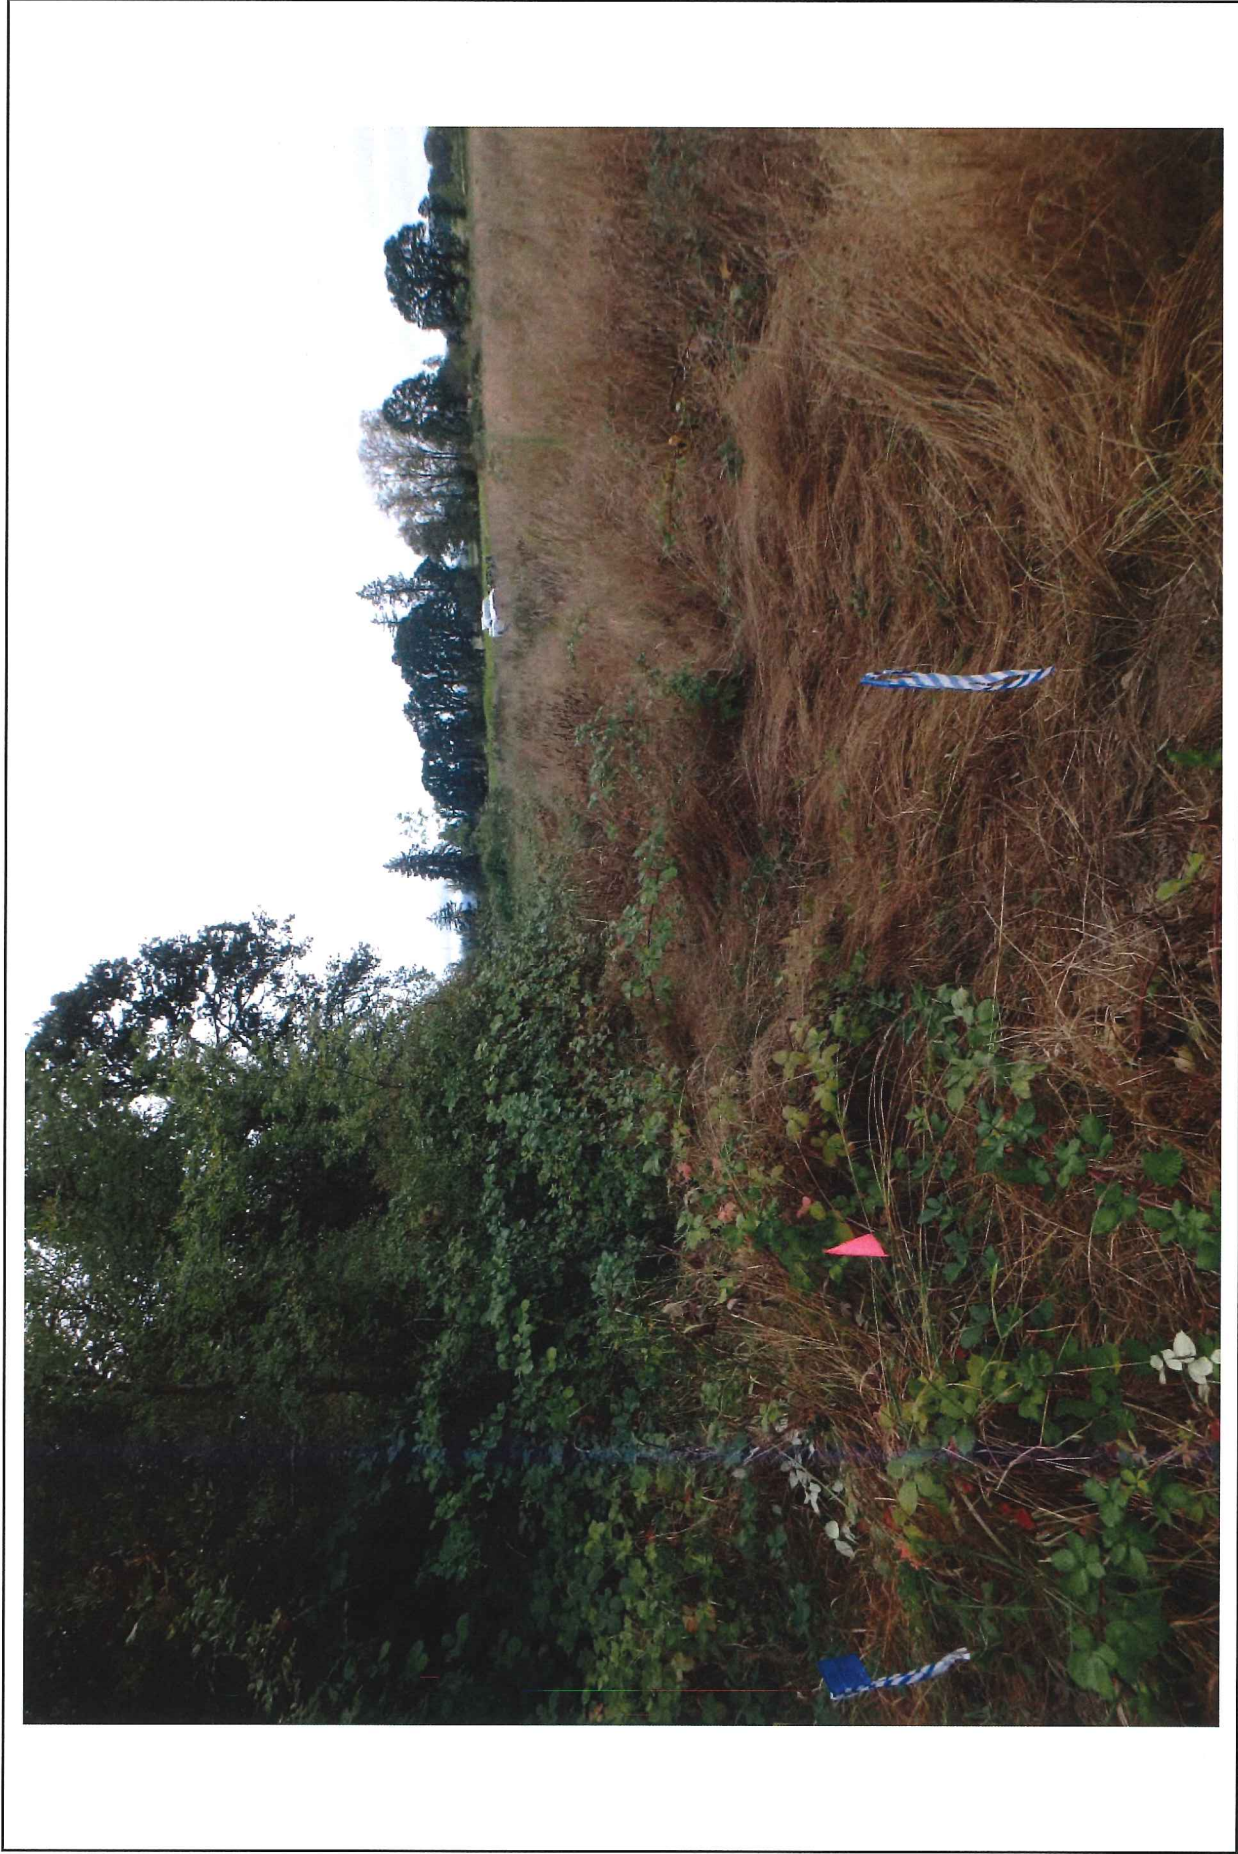
Appendix F, Photo 12
Degraded Condition Vegetated Corridor along Wetland F, Looking Southwest
Natural Resource Assessment (Bellairs and Lolich Properties)
West Hills Land Development: The Ridge at South Cooper Mountain

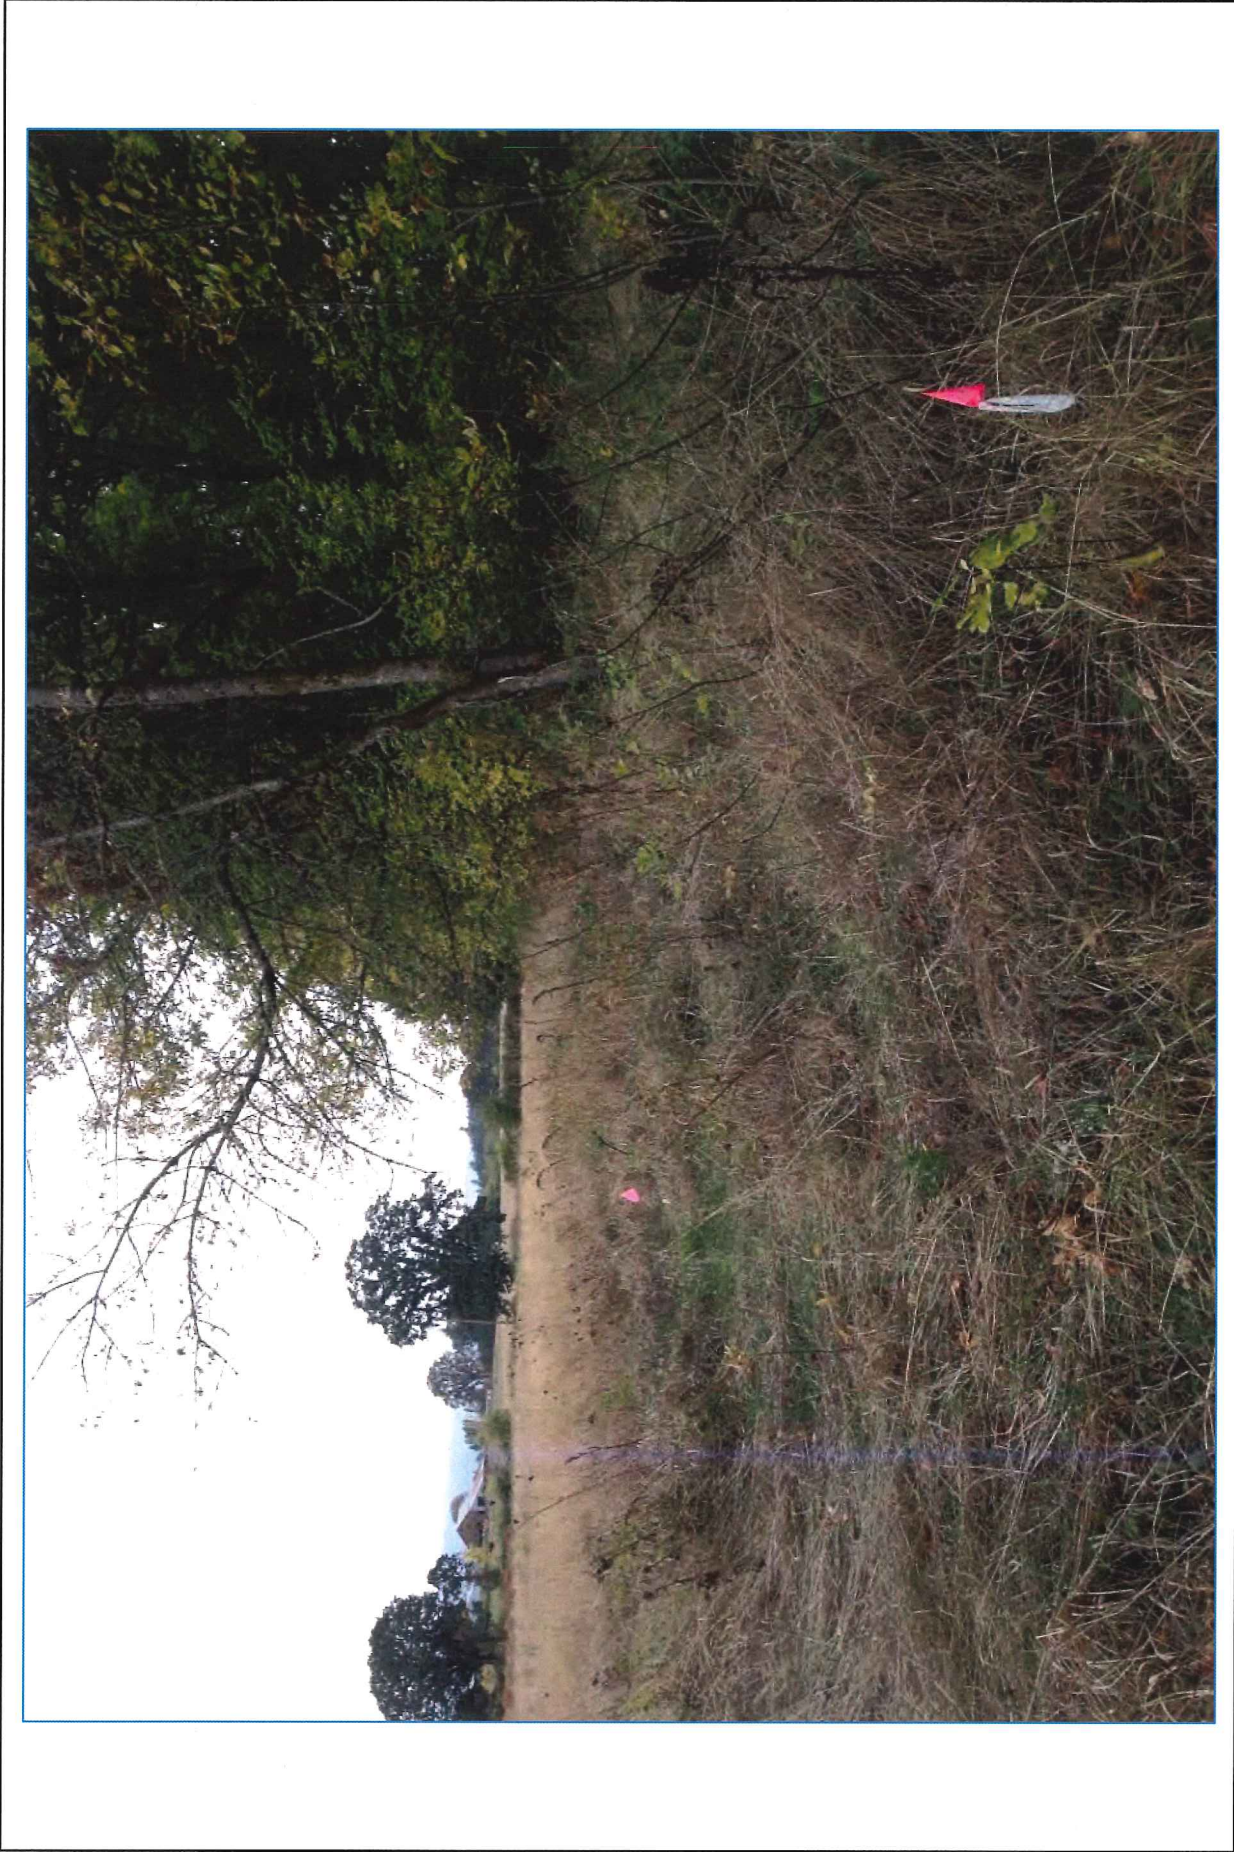
Appendix F, Photo 13
Degraded Condition Vegetated Corridor along Wetland G, Looking Southwest
Natural Resource Assessment (Bellairs and Lolich Properties)
West Hills Land Development: The Ridge at South Cooper Mountain

Fish habitat is not present in Wetland G; it does not contain a stream, pond, or lake and has no direct surface water connection to other waterbodies. These conditions prevented Wetland G from receiving an *Intact* rating for this function, which is required for the wetland to be considered locally significant for fish habitat.

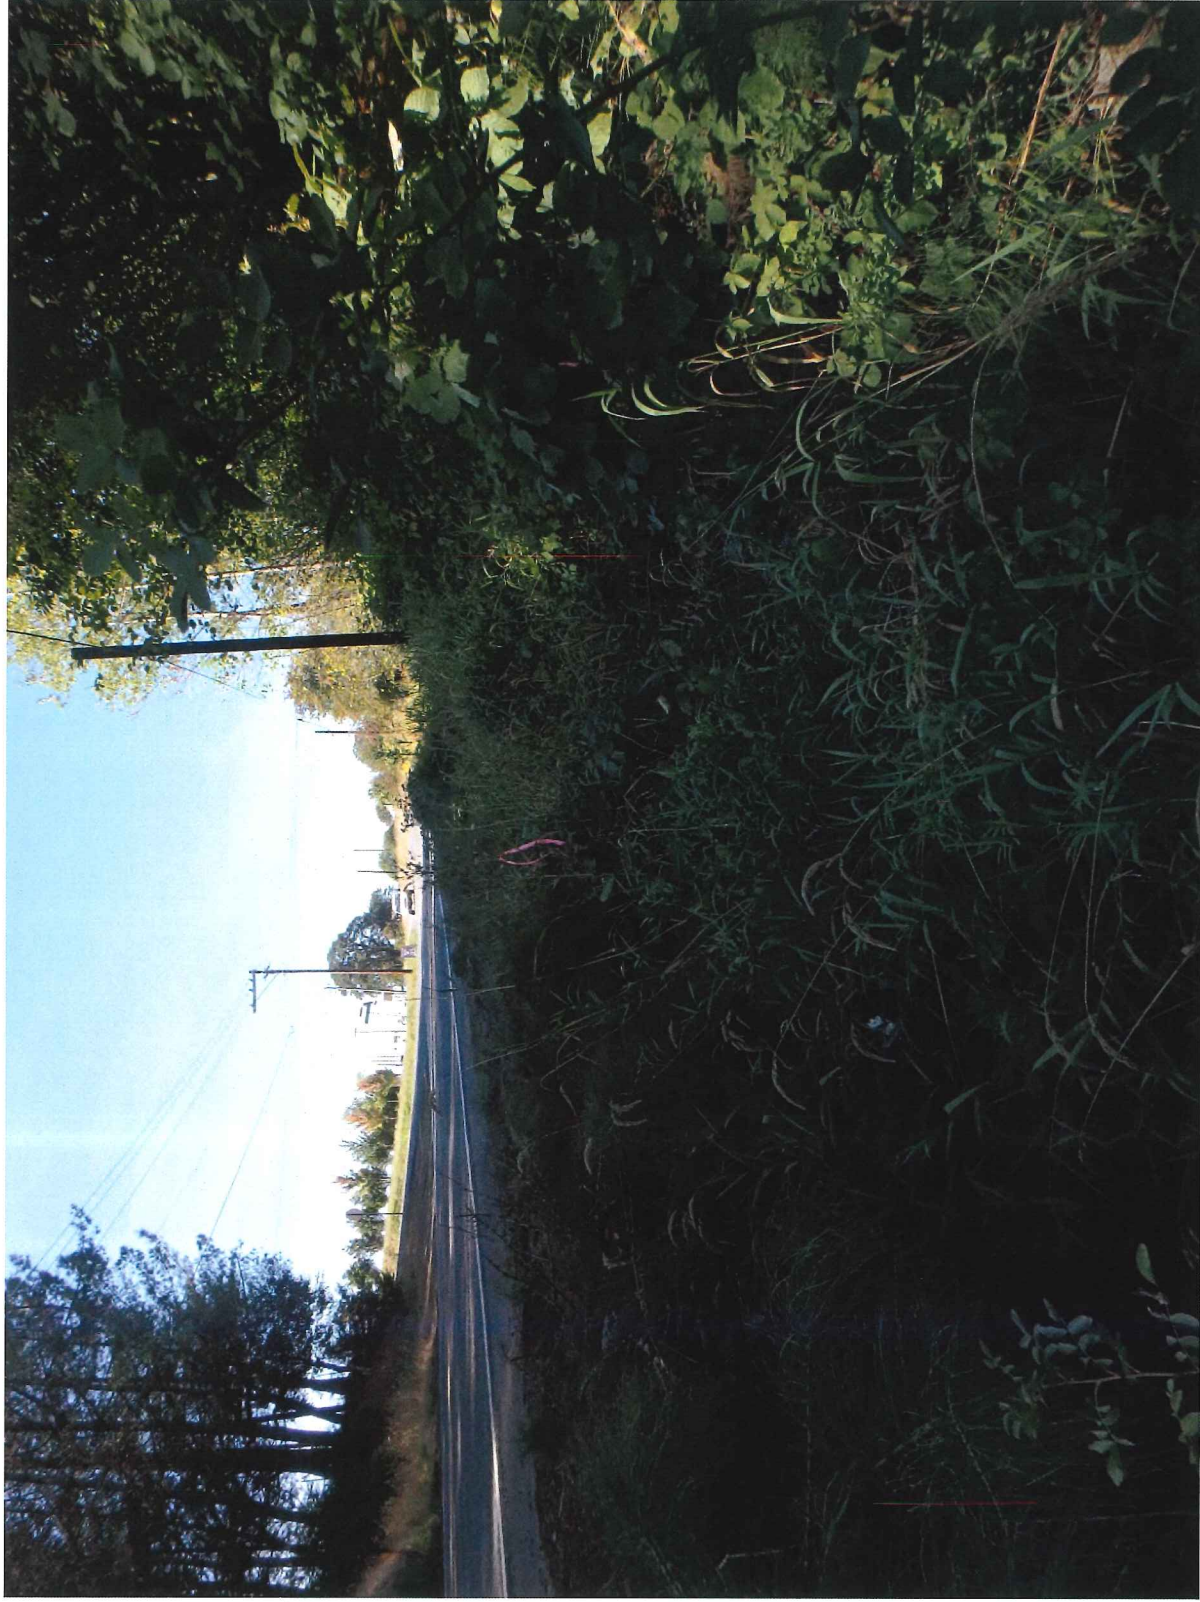
The degraded vegetated corridor along the Southwest Drainage is dominated by common hawthorn and Himalayan blackberry, with lesser amounts of black cottonwood, Oregon ash, Saskatoon (*Amelanchier alnifolia*), bigleaf maple (*Acer macrophyllum*), beaked hazel (*Corylus cornuta*), common snowberry, and rose species (*Rosa* spp.). The herbaceous layer is sparse and includes scattered western sword fern, taper fruit short-scale sedge, Herb Robert (*Geranium robertianum*), Fringe cup (*Tellima grandiflora*), fringed willowherb, and common horsetail.

Appendix F, Photo 18
Degraded Condition Vegetated Corridor along Southwest Drainage, Looking West
Natural Resource Assessment (Bellairs and Lolich Properties)
West Hills Land Development: The Ridge at South Cooper Mountain

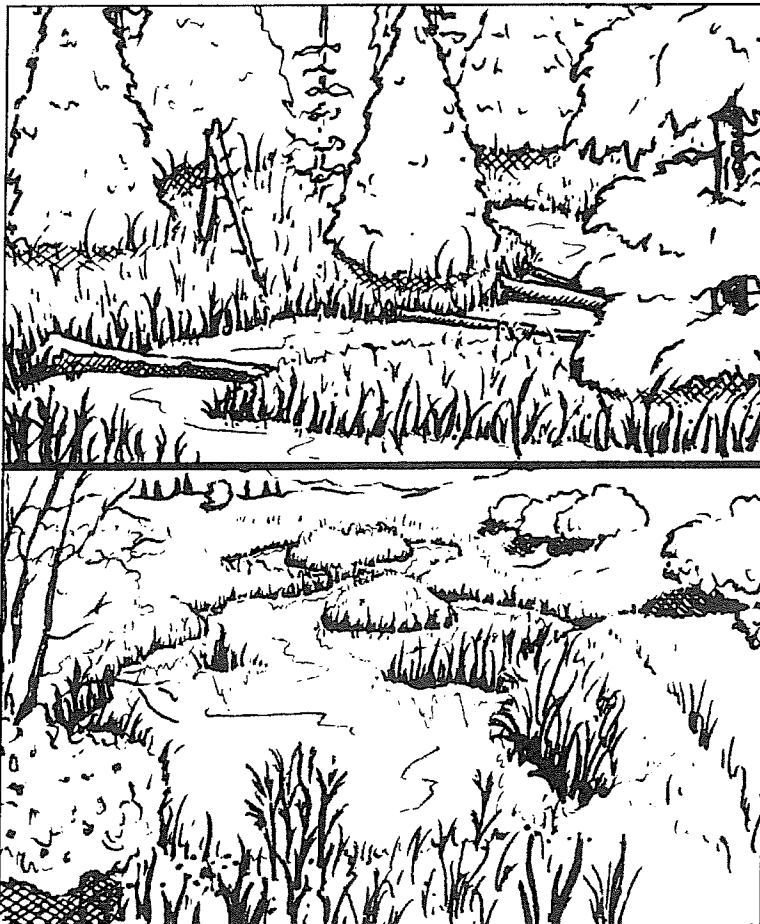
Figure 6. Visual contrast.

The top part of the figure shows a wetland with significant visual contrast with the surrounding landscape. The bottom part shows a wetland with little or no visual contrast with the surrounding landscape.
