Impact Study A

**Natural Resource Assessment dated February 2017;
Memorandum “The Ridge at South Cooper Mountain Residential
Development Oregon Freshwater Wetland Assessment Method (OFWAM)
Analysis for Wetland G” dated January 10, 2017;
Response to request for additional materials dated March 28, 2017;
Memorandum “Wetland G Local Significance Determination”
dated May 3, 2017 by
Anchor QEA LLC**

Memorandum

**Re: The Ridge at South Cooper Mountain Residential Development Project:
Wetland G Local Significance Determination**

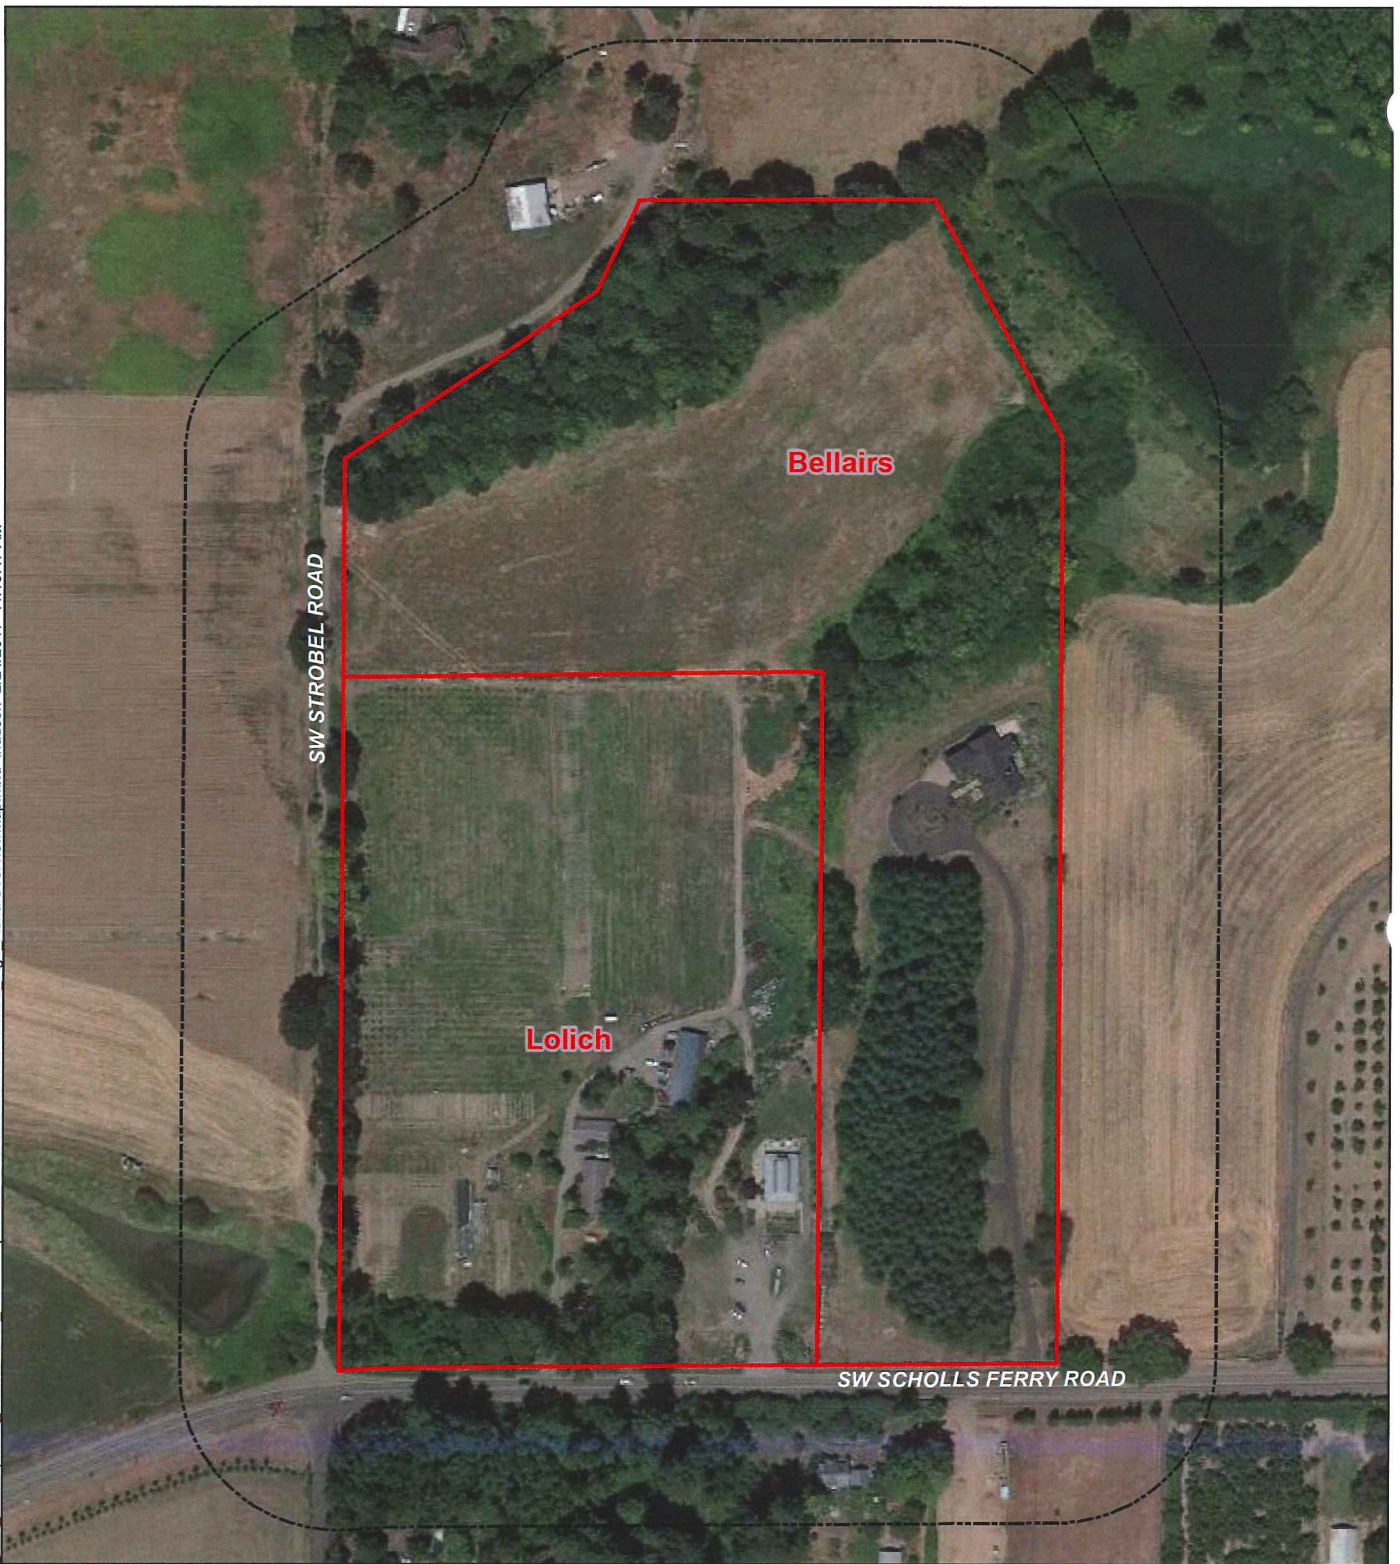
The current conditions of the study area are depicted in the 2016 aerial photograph provided in Figure 4. As indicated in the figure, the Bellairs property includes a mix of land uses including a forested area and fallow agricultural field in the northern portion, a wooded-stream corridor and single-family residence in the central portion, and a Douglas fir (*Pseudotsuga menziesii*) woodlot in the southern portion. The Lolich property is primarily composed of agricultural fields in the northern and western portions and associated agricultural buildings, including a commercial farm stand and parking lot, in the

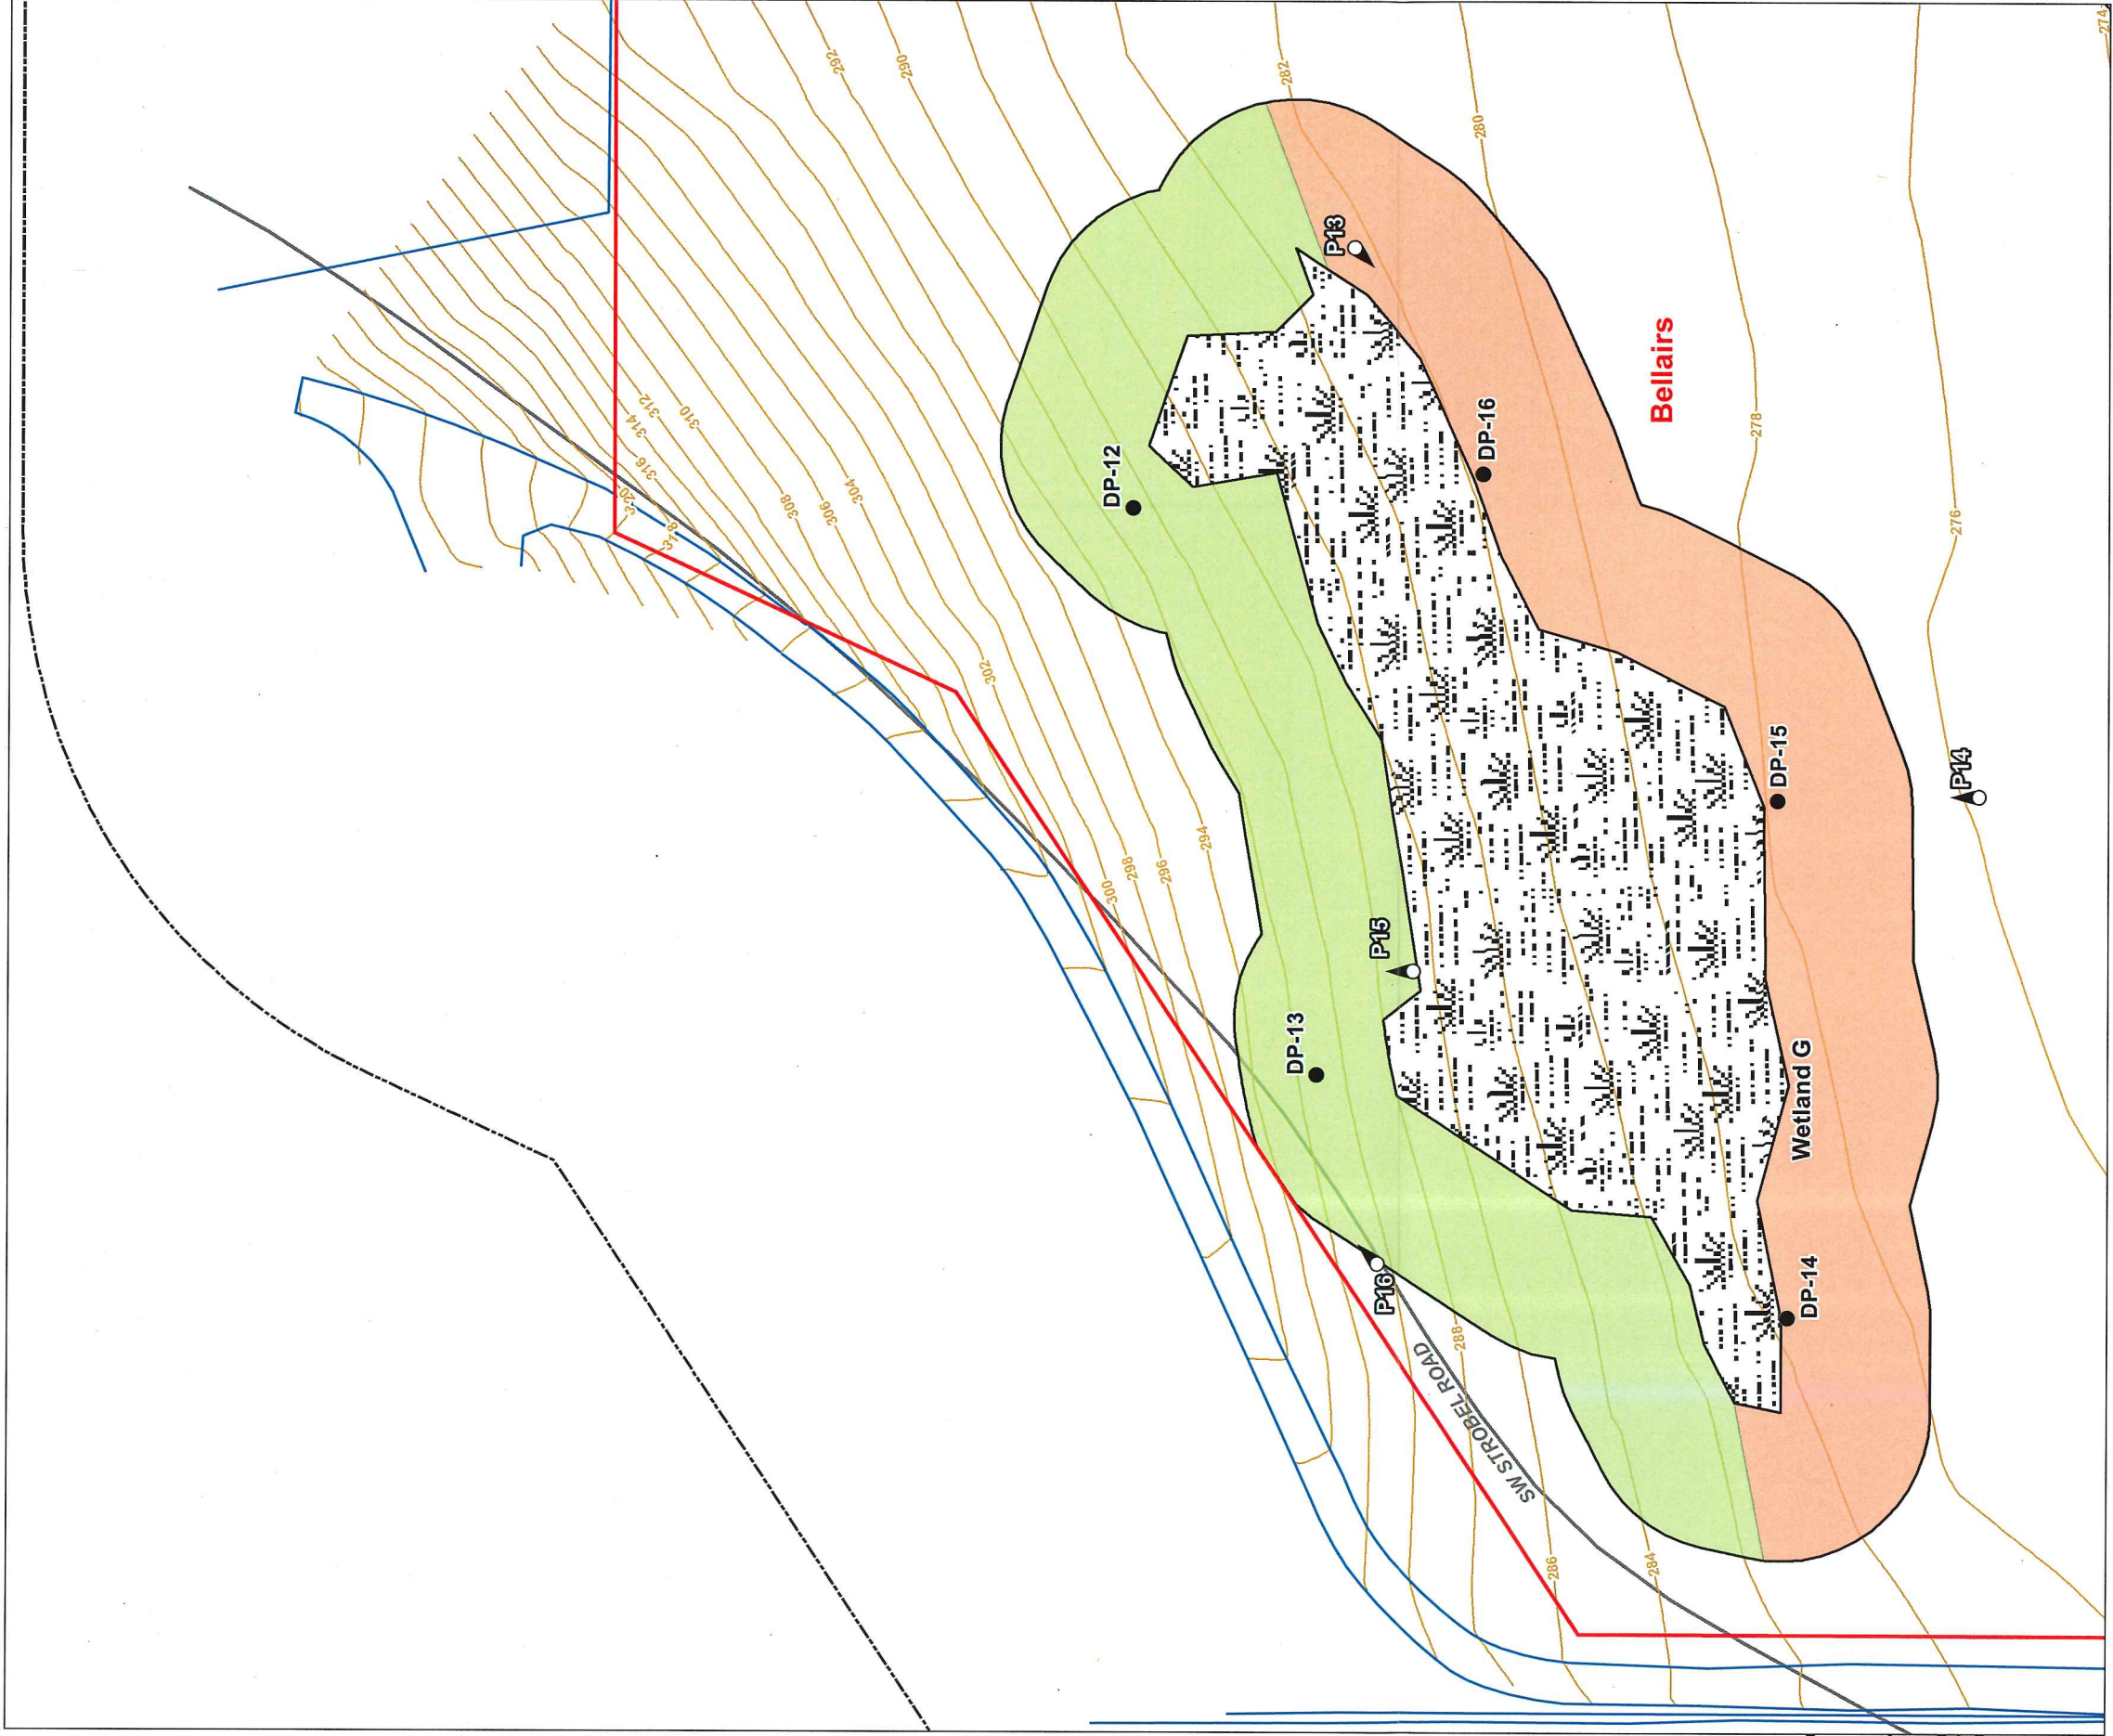
Figure 6b
 Existing Conditions Map
 Natural Resource Assessment (Bellairs and Lolich Properties)
 West Hills Land Development: The Ridge at South Coon Mountain

Project Site Boundary On-site Sensitive Area Good Vegetated Corridor (60,554 sq ft)
 Study Area Boundary Delineated Wetland Degraded Vegetated Corridor (137,653 sq ft)
 Road Vegetated Corridor
