Natural Resource Assessment

SW Westgate and SW Hall

Township	Range	Section	Tax Lot
1 South	1 West	09DD	105

February 3, 2023

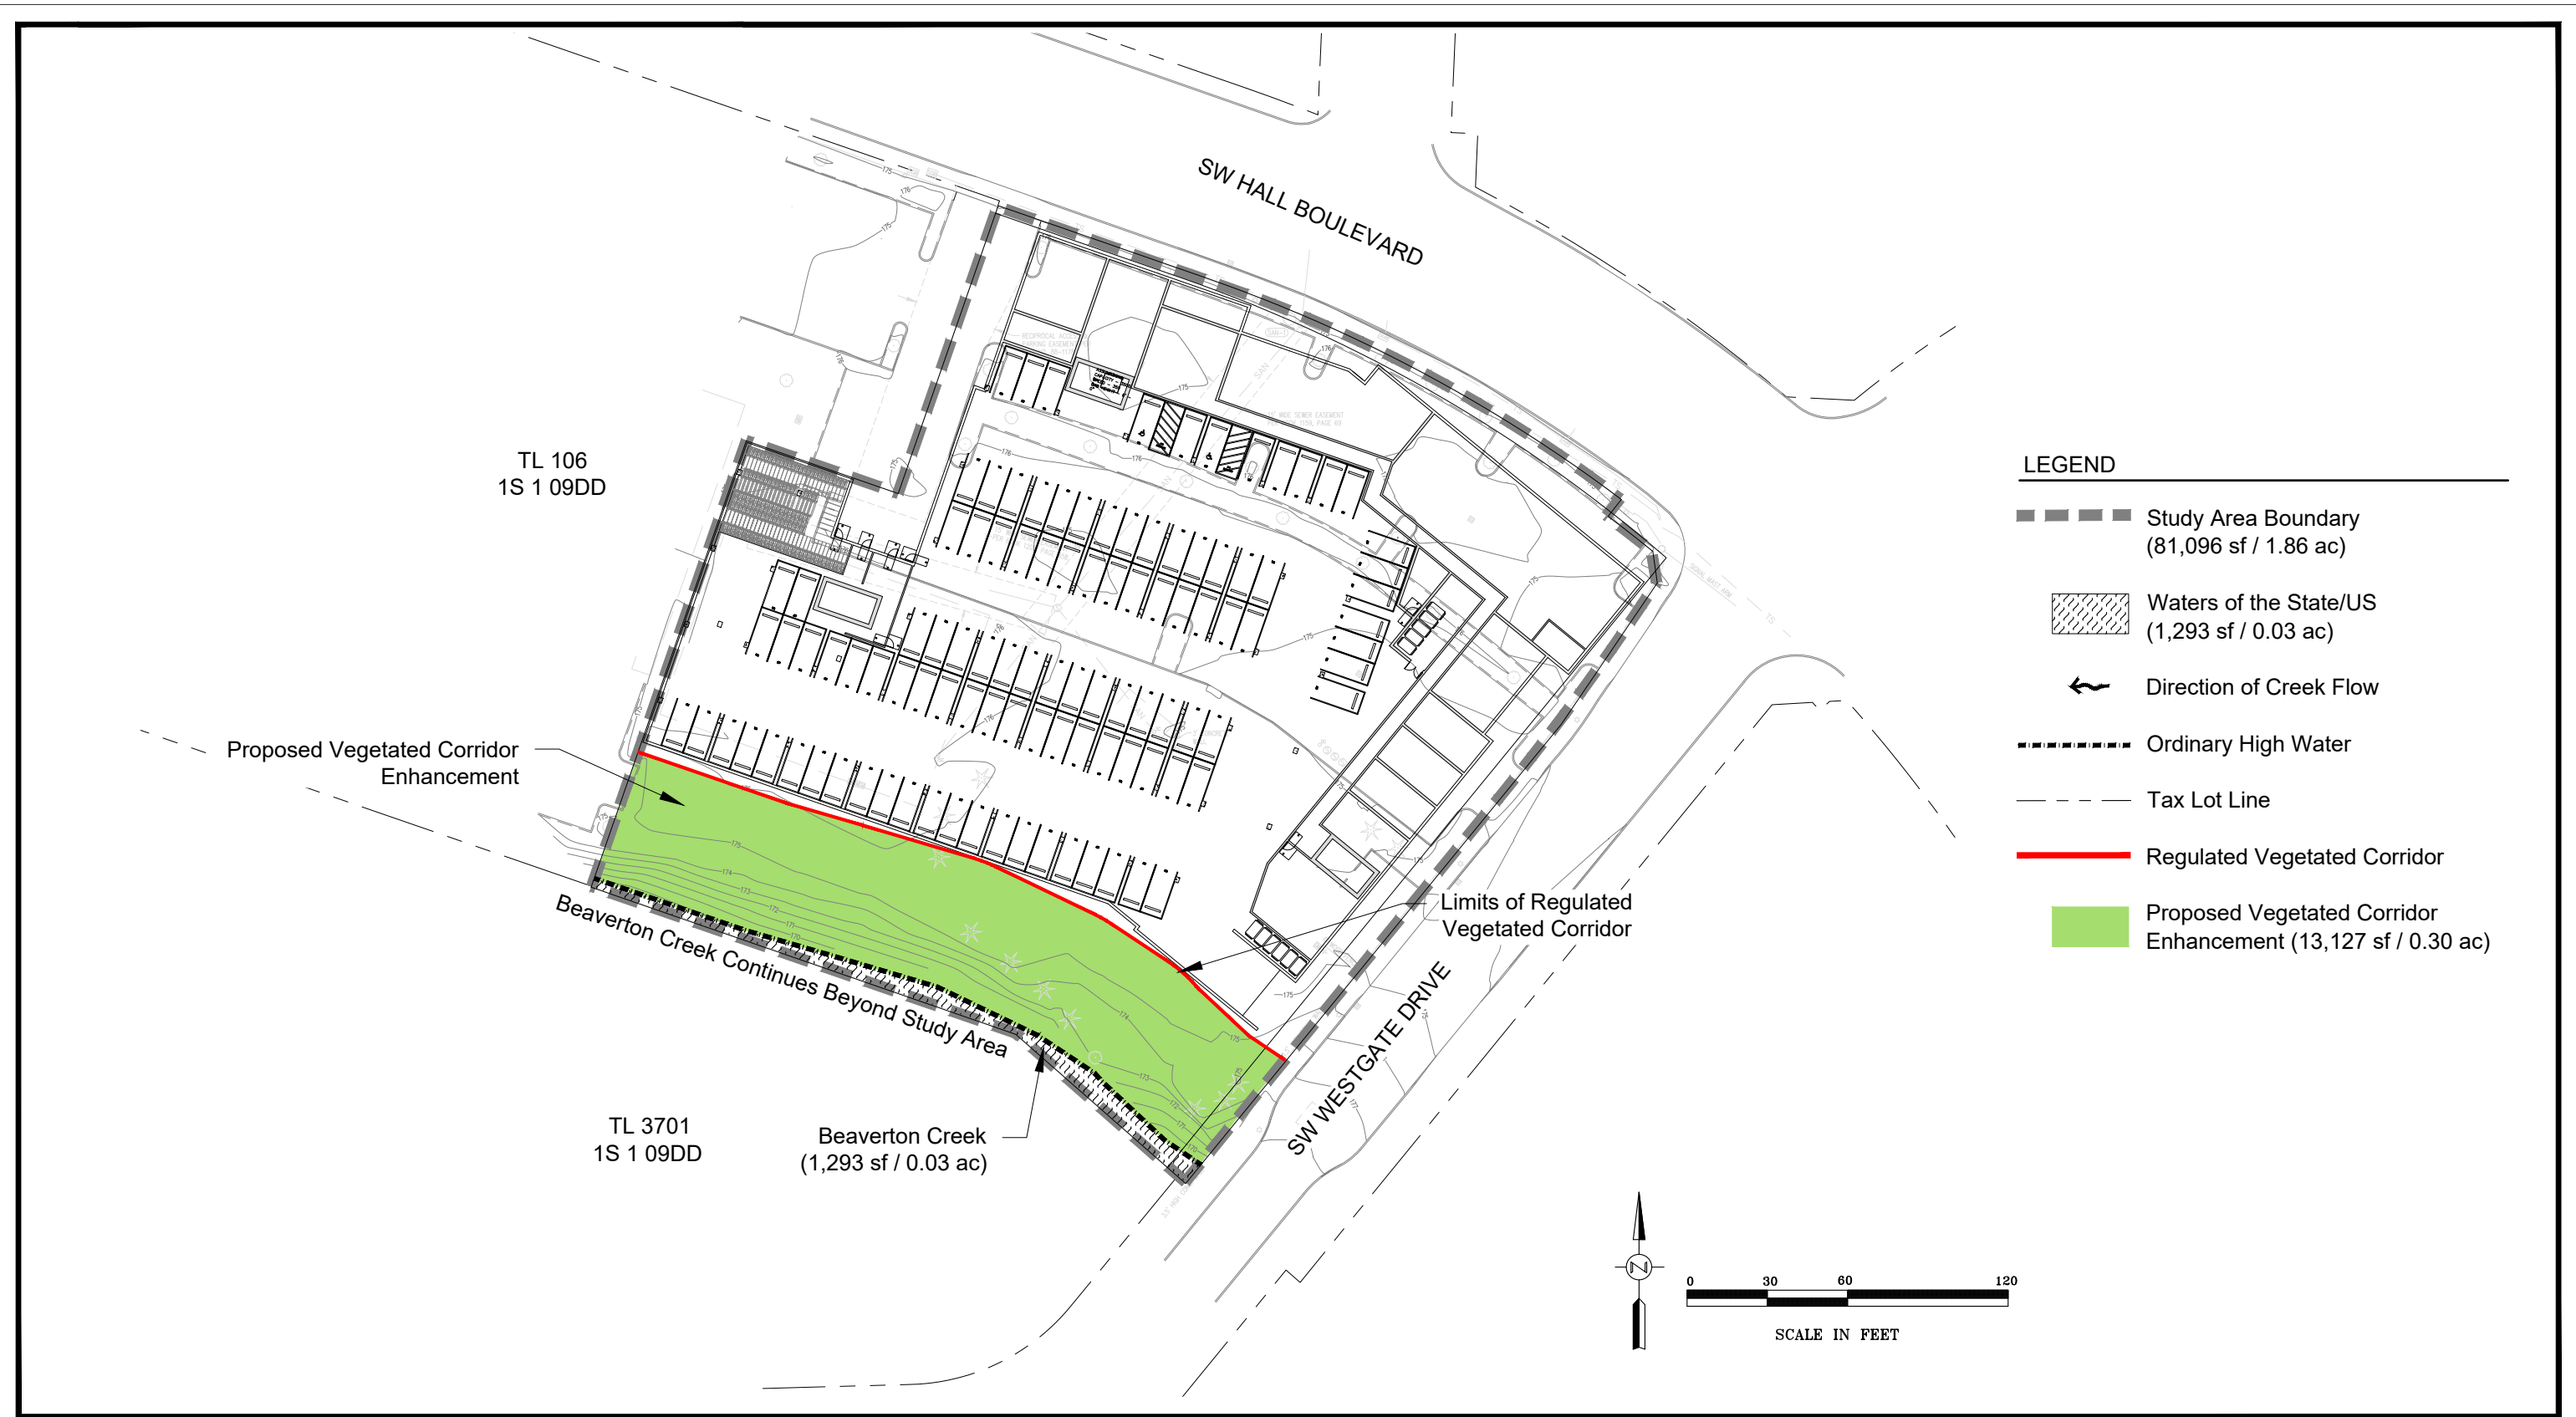
Vegetated Corridor Enhancement
Hall and Westgate - Beaverton, Oregon

The entire onsite VC north of Beaverton Creek (13,127 square feet) will be enhanced to “good” corridor condition, including the area currently covered by an existing patio and building (Figure 5) This is an increase in area of onsite VC of 974 square feet over current conditions. All plant communities are currently in marginal or degraded condition. Enhancement will include the removal of invasive species and the planting of native trees and shrubs. Bare soil will exist where the patio and eastern building are to be removed; enhancement in these areas will include the application of a native seed mix. All plants to be installed will be in compliance with the spacing, density and native species requirements per CWS’s Appendix A “Planting Requirements” for trees and shrubs. Due to the extent of canopy cover in the eastern half of the VC, the standard density of trees in the east half of the corridor will be decreased by 50%.

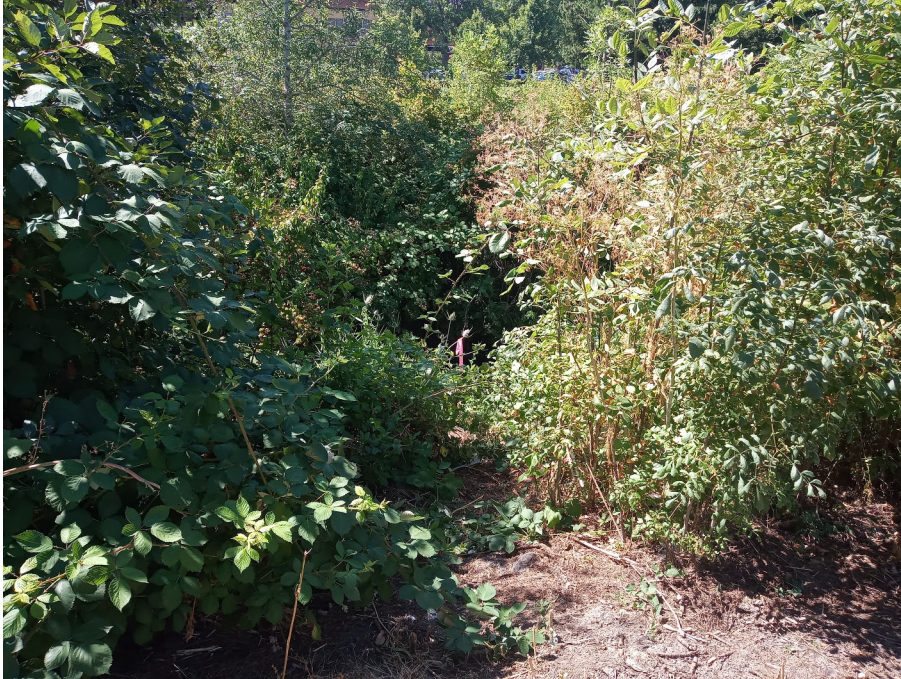
Photo A:

Photo view to the south towards Beaverton Creek. The pink flag corresponds to the location of SP-1 just above the creek.

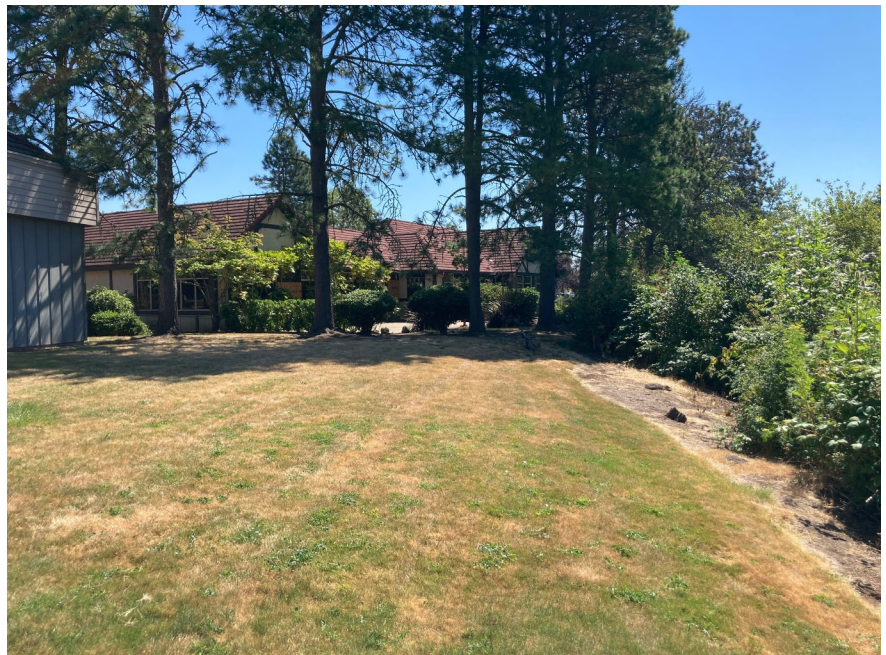
Photo B:

Photo view to the southeast. Community C is in the foreground, with Community A (the blackberries) to the right and Community B beginning at the line of ponderosa pines.

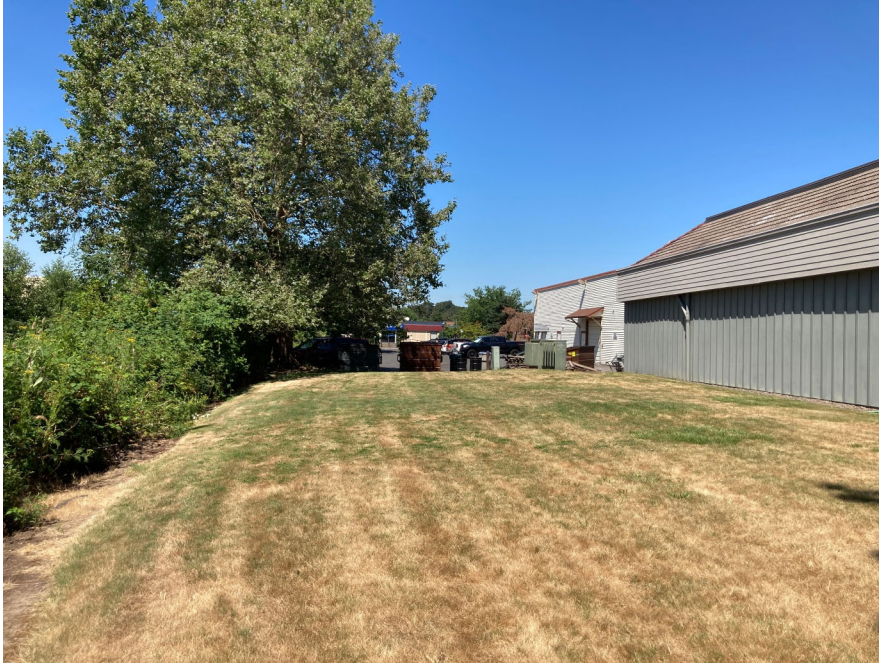
Photo C:

Photo view to the northwest. The site continues to the large tree in the background. The photo foreground is Community C, with Community A to the left.

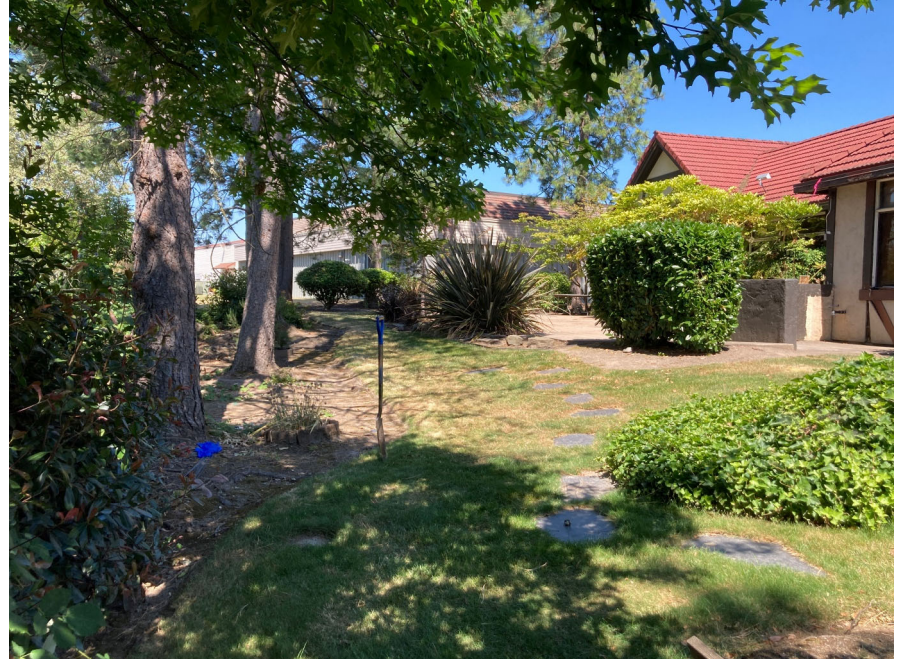
Photo D:

Photo view to the northwest across Community B.
