GEOTECHNICAL REPORT

**Scholls Ferry Apartments
18865 Southwest Scholls Ferry Road
Beaverton, Oregon**

Project No. T-8600

Terra Associates, Inc.

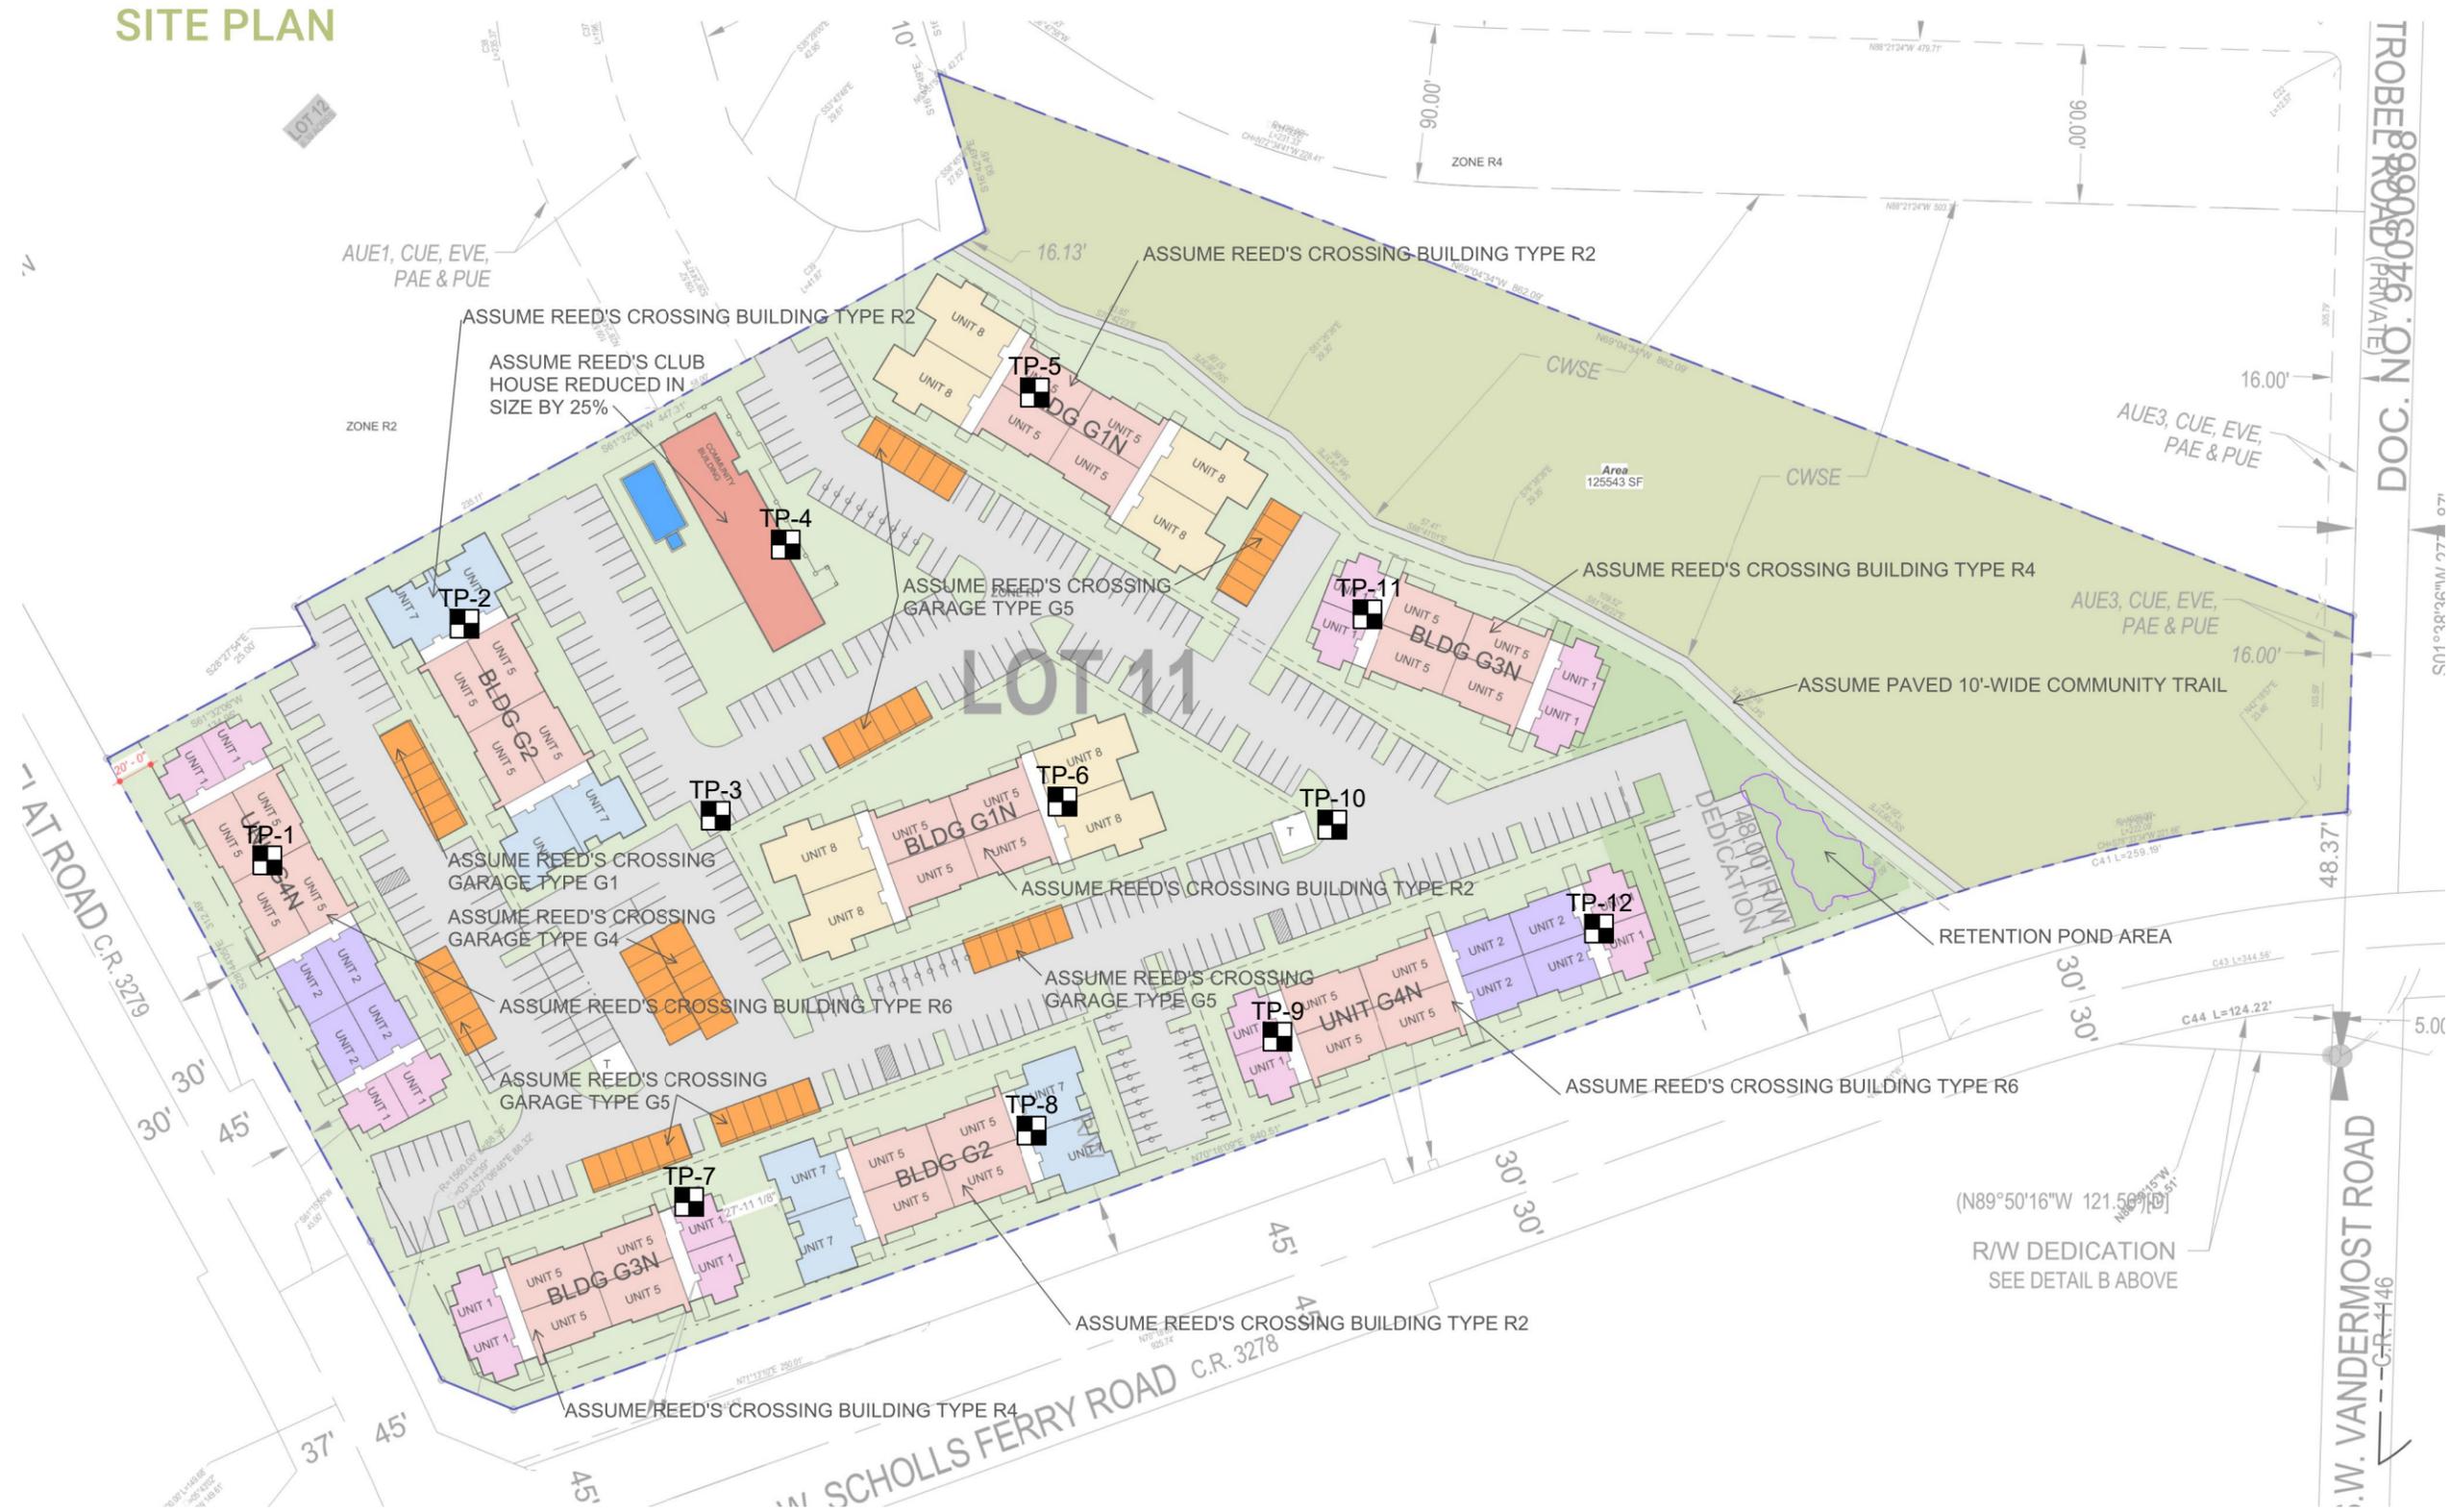
THIS SITE PLAN IS SCHEMATIC. ALL LOCATIONS AND DIMENSIONS ARE APPROXIMATE. IT IS INTENDED FOR REFERENCE ONLY AND SHOULD NOT BE USED FOR DESIGN OR CONSTRUCTION PURPOSES.

On August 18, 2021, we explored subsurface conditions at the site by excavating 12 test pits to maximum depths of 10 to 12 feet below existing surface grades using a track-mounted excavator. The test pit locations were approximately determined in the field by sighting and pacing from existing site features. The approximate test pit locations are shown on Figure 2. The Test Pit Logs are presented as Figures A-2 through A-13.
